## Description of incident:

During planned maintenance on a barrel type casing compressor operating in a marine environment, one of the M30 end cover stud bolts was inadvertently knocked and failed.

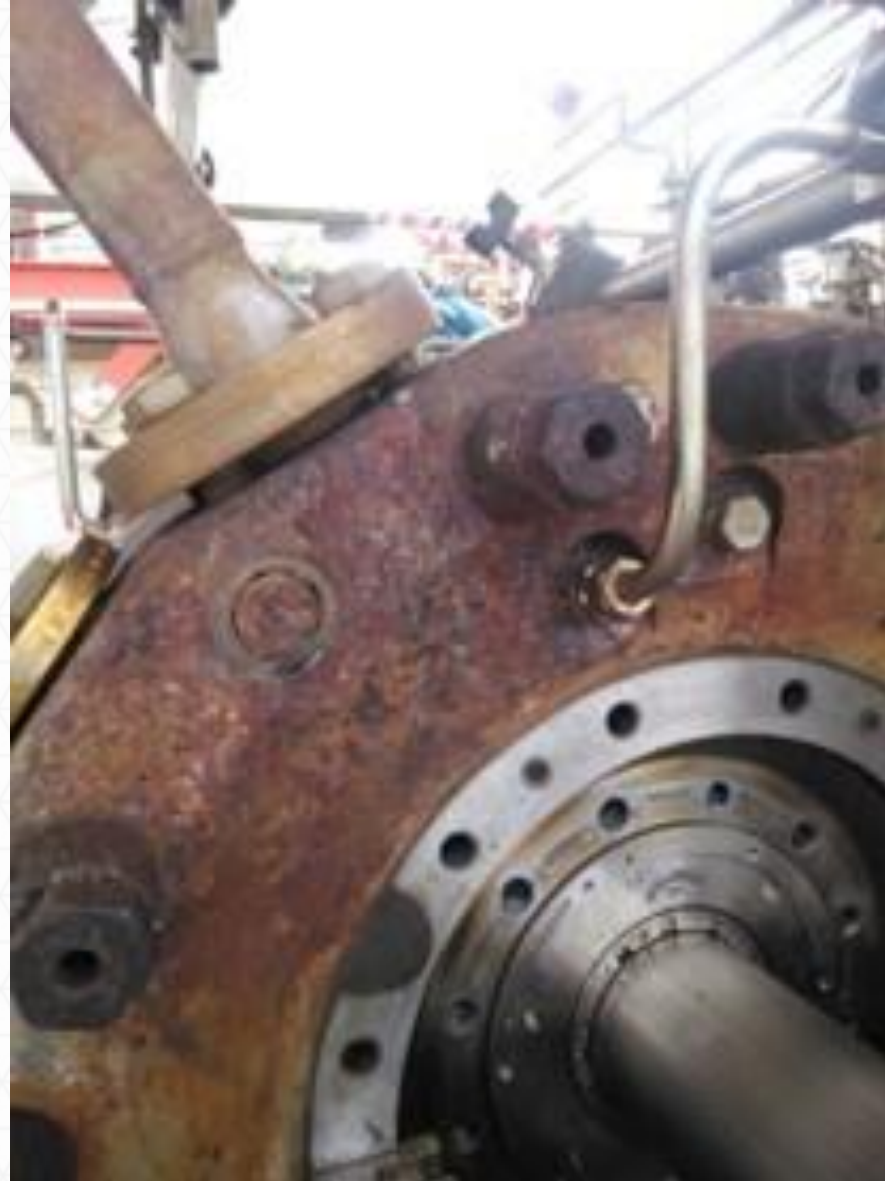
Upon further inspection a number of the stud bolts were found to have failed or cracked.

Metallurgical examination revealed that in each case the studs had fractured at the area of highest stress concentration at the first engaged thread with the nut, caused by hydrogen induced stress corrosion cracking from exposure to moisture in the marine environment.

The material was to the correct OEM specification. No specific change out interval was defined by the OEM.

For marine environment installations, consider carrying out immediate inspection of End Cover Stud Nut Bolts where the life of the bolting cannot be determined, or historical inspection results are unavailable.

Consider setting a service life for End Cover Stud Nut Bolts appropriate to the operating environment and incorporating into planned maintenance.
