Description of incident:

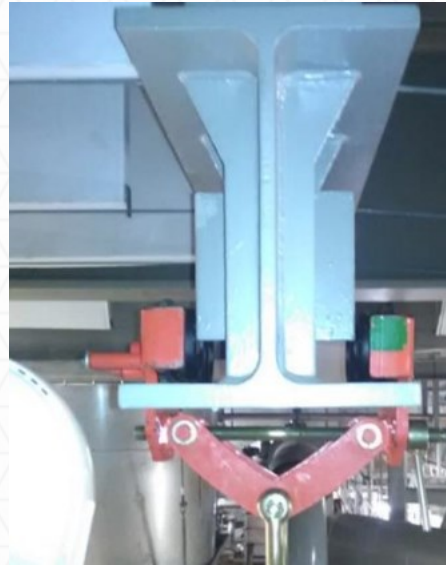
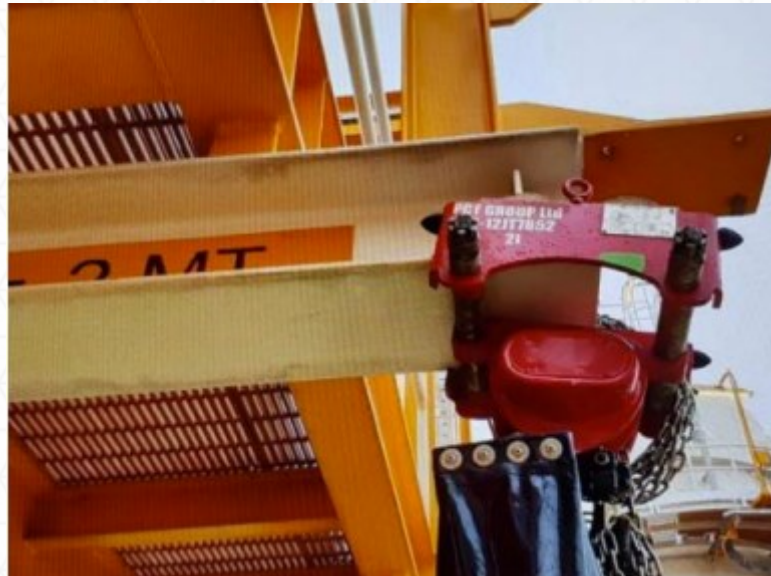
A manual gear trolley was reported to be partially disengaged from the monorail. No activity was carried out around the location at the time of discovery. Potential drop of 2.3 meters for a 52 kg weight.

A trolley was installed on the beam above a pump for its maintenance. The end stop was tested by the lifting team from the ground (i.e. 6 meters below) running it towards the edge. The trolley did stop yet there was no visual observation of its contact with the end stop. The following days, in the course of the maintenance activity, the trolley fell down on a nearby platform (3 meters below the beam). None of the 4 personnel presents in the vicinity were injured. Potential drop of 3 meters for a 40 kg weight.

In both cases it appears that the manual geared trolley when reaching the end of the beam was not stopped by the beam stopper due to the fact that the mechanical stopper was not wide enough to make contact with the trolley itself.

- Ensure that endstoppers are fitted on beams. Beams fitted without endstoppers shall not be used and marked accordingly onsite.
- Based on available documentation, ensure that the width of the endstoppers is adapted to the size of the monorail bottom flange and to the type of trolley.
- In all cases, ensure that the functional test including a visual check of endstoppers effectiveness is carried out after each trolley installation. Include this test within the site procedures
