Dropped GRP cover during subsea lifting

Safety Flash Published on 22 January 2026 Generated on 28 January 2026 IMCA SF 02/26

A vessel was lifting and relocating a Pipe Line End Manifold (PLEM) GRP Top Cover when the load became detached and dropped approx. 7m.

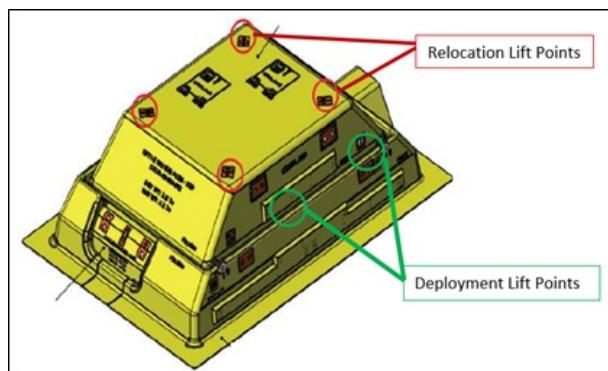
A vessel was lifting and relocating a Pipe Line End Manifold (PLEM) GRP Top Cover when the load became detached and dropped approx. 7m, landing on the side of the PLEM bottom GRP structure. The fibreglass lifting points failed on the GRP cover, but there was no damage to the PLEM or bottom GRP structure, nor any injuries to personnel.

The Top Cover has two different types of lifting points. One set is designed for deployment and consists of pairs of profiled, reinforced holes where round slings are routed. The other set is designed for subsea relocation and consists of bars designed for easy connection to ROV hooks.

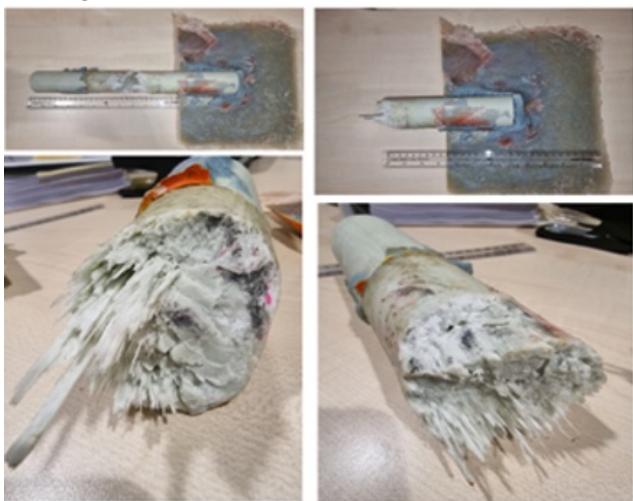
contact with the GRP cover it was found to have completely detached from the lift rigging, had flipped over on to its back and come to rest partially on the side of the PLEM bottom GRP structure.

- The crane had to be in heave compensated mode to avoid the hydrodynamic loads overloading the cover. However, the direct switch from ACT to AHC was not possible on that specific crane and there was an intermediate stage where the load was required to be in 'normal' mode. This short period was enough to cause an excessive load on the lift rods.

- The calculation package for the lifting rods was erroneous and resulted in an undersized rod/overestimated load capacity - even though the pins were overloaded, they failed at a lower value than should have been expected.

- An ALL STOP was called, all key stakeholders were informed;
- ROV survey of the worksite;
- Management of Change process initiated:
 - A new lift plan was created to cover the operations of upending, lifting, and relocating the GRP cover
 - The requirement to use "Active Constant Tension" was removed to avoid the need of a crane mode switch
 - Future lifts utilised the 'deployment' lift points
- All crane, video, witness statements & physical evidence collated and an investigation initiated.

- The lift plan should have either used AHC throughout and used other control measures to mitigate against the initial snag risk, or the weather criteria for the lift have been based on 'normal' mode and the lift plan reflecting the required mode transition phases.
