Description of incident:

A 2' scaffold tube with a right angle attached fell 25' grazing an employee's left shoulder and knee before landing on the ground in front of them.

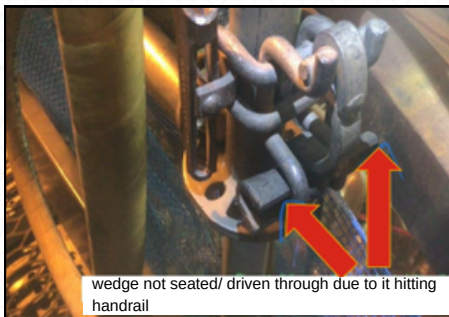
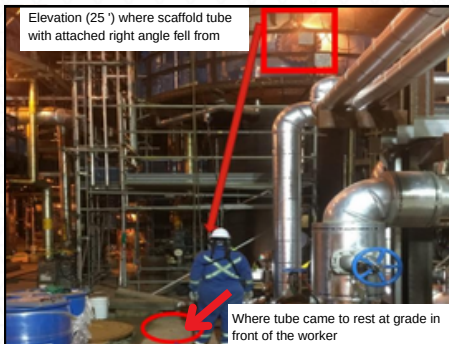
- It was determined the band and wedge of the right angle had come loose over time due to vibration.
- Wedge on right angle holding the scaffold tube was driven the wrong direction and was butted up against the handrail.
