Employee fell into the cable pit

SAFETY ALERT

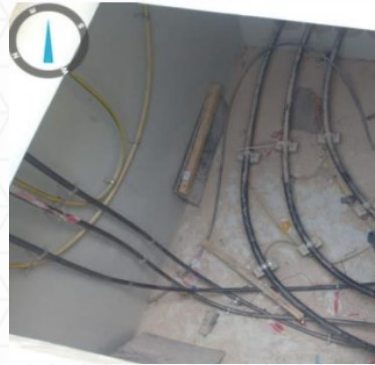
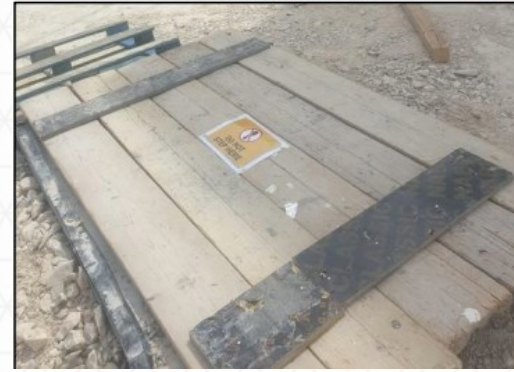
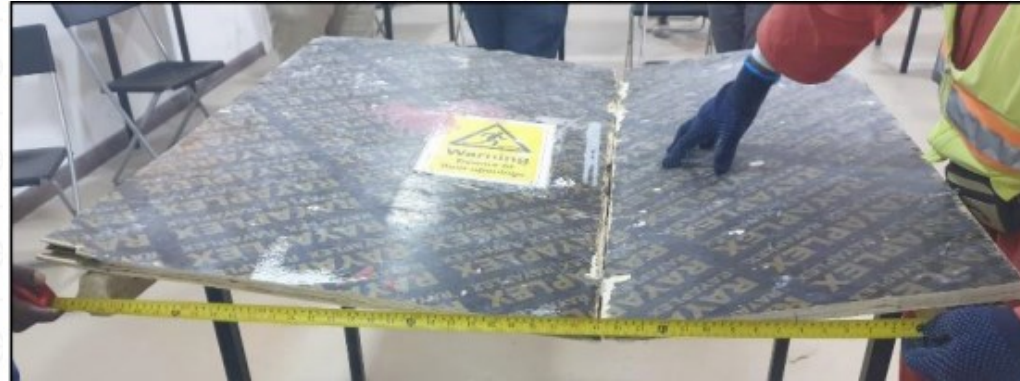
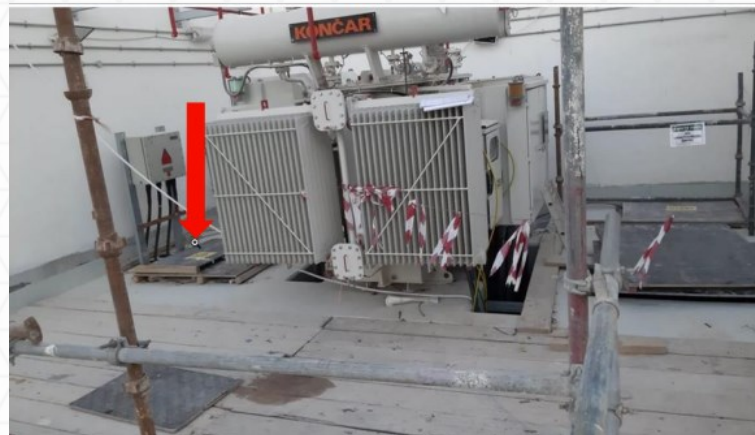
During daily site tour, the site operator, contractor and sub-contractors' attendees were inspecting the auxiliary transformer area for work progress (site is under construction). The IP stopped on top of the cable pit, which was temporarily covered with a plywood board.

The IP was unhappy due to the delay in work progress, the day before he had asked to install the permanent cover slabs. Consequently, he stomped his feet on the plywood cover. The plywood broke and IP fell into the pit/cable trench from a height of 3.1 meters, on the cables installed. Following the incident the plywood cover was replaced with a cover compliant with scaffolding standard with safety sign.

The area was hard barricaded (scaffolding) to restrict the access of unauthorised personnel. On the day before the accident, during the daily tour, IP instructed contractor & Subcontractor to remove all scaffolding barricades, and to install the permanent cover slabs (Concrete slabs) on the same day. On the day of the accident, they noticed that the hard barricade had been removed but the slabs had not been installed. There are no standards recognised by contractor for plywood design as a cover neither method statement, risk analysis or work at height procedure. At the time of accident, one single plywood cover was installed, with wooden support alongside the nib.

The single plywood had the caution/hazard sign "Floor Opening", did not have tags with unique number. At the time of removing the hard barricade, no inspection was performed. There is no specific checklist for checking temporary floor covers, no tracking with tags. There is no management of change procedure at time of scaffolding/barrier removal, no inspection performed to check safe area.

- No standards for plywood design as cover identified.
- No management of change procedure available for removal of engineering controls / collective protection.
- No regular inspection performed on cover.
- Existing practice not detailed into risk assessment or method statement.
- Hand over between civil and electrical does not mention/identify covers or temporary equipment.
- Safety and behaviour refreshing training to improve risk perception, safe work supervision and constructive follow up.
