Hand tool Lithium battery fire in moonpool

SAFETY ALERT

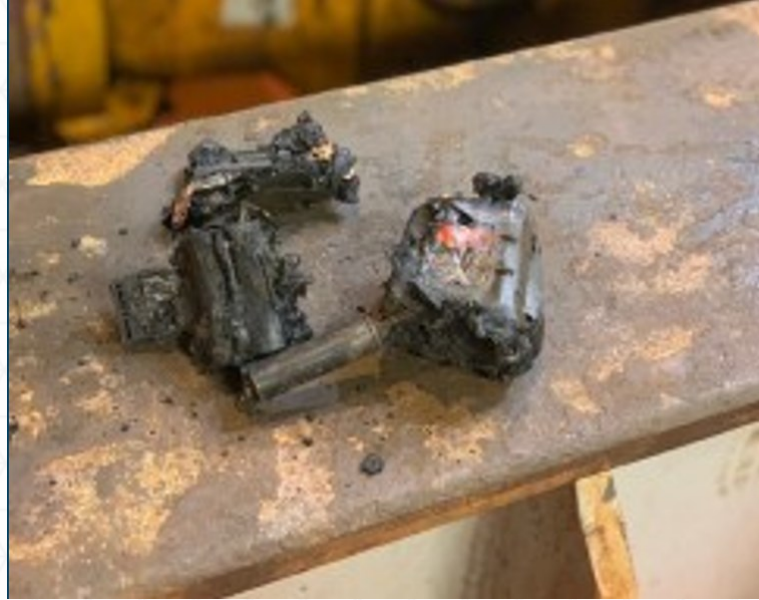
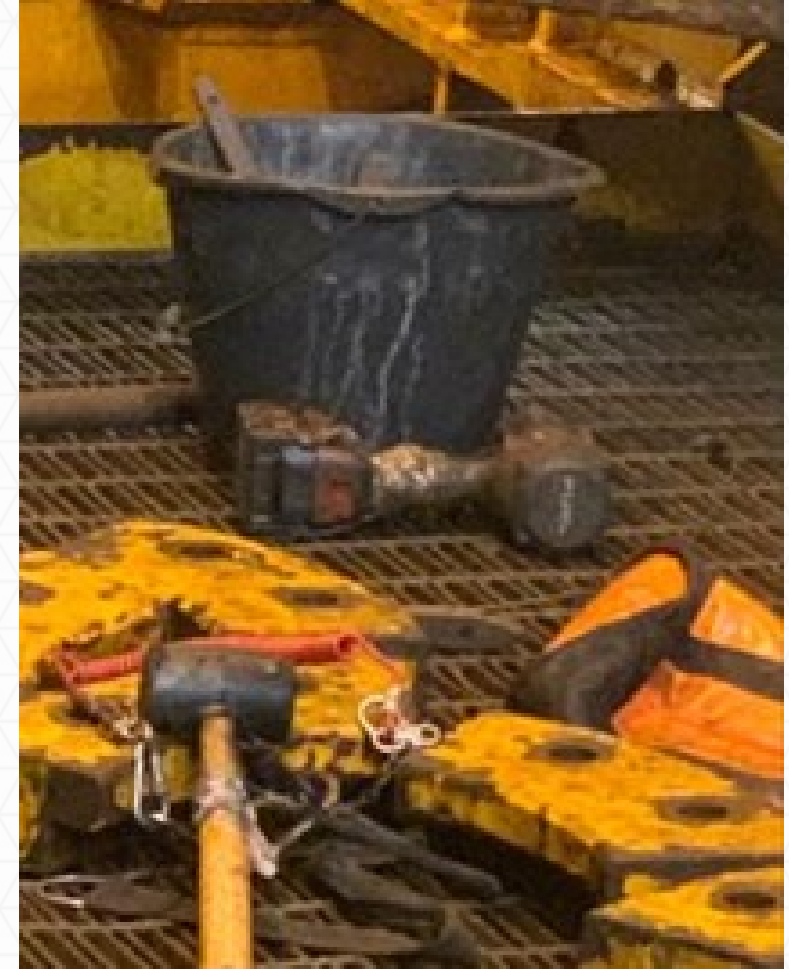
The BOP transporter platform was inspected, and the burned remains of the power tool lithium battery was identified as the source for the flame. The battery was not connected to any tool.

Cause - The lithium battery was exposed to a liquid/wet environment and caused a meltdown/burst into flame

Consequence – Damaged battery

- Always carry out pre-use checks of tools/equipment
- Use and store tools/equipment in accordance with the user manual
