# Head Injury Due to Windssock Mast Failure

**SAFETY ALERT**

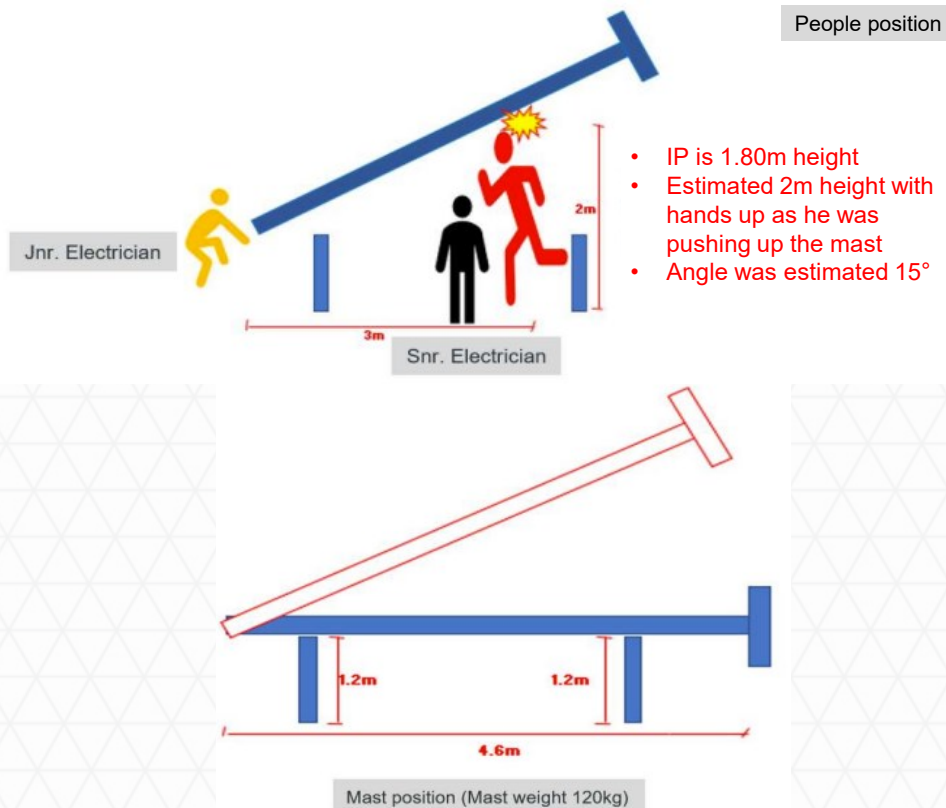
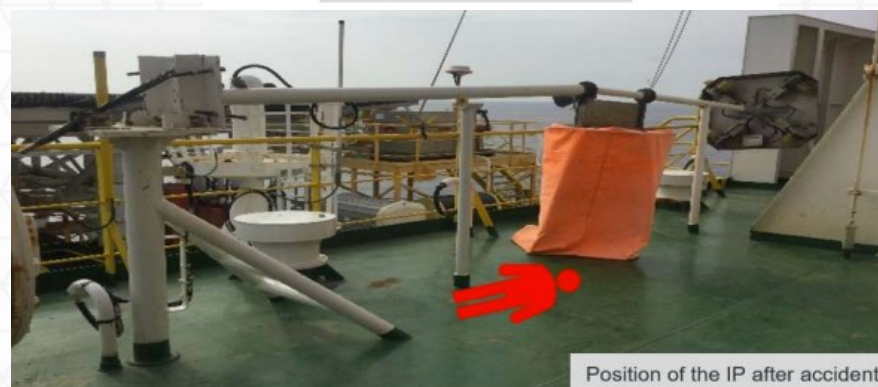
While jacking up of the mast was taking place, the IP moved away from the mast when a mechanical failure of the jacking bolt assembly occurred causing the windssock mast to rapidly come back down.

IP did not manage to get out of the line of fire of the descending mast in time and mast struck IP on his head. IP was not wearing a hard hat.

- Castle lock nut was found worn out.
- Jacking bolt assembly was wrongly assembled. Both washers found at the bottom below the bushing and no washer underneath the castle nut. The bushing makes direct contact against the castle nut. Torque is created by the friction between the threads of the male (rod) and female (nut).

- Routine activities should be risk assessed.
- Only competent persons should undertake tasks referencing corresponding procedures and work instructions.
- Windssock mast mechanism and similar equipment should be subject to regular inspection and preventive Maintenance.
- Continuous reinforcement of Line of Fire awareness and stopping the job.
- Relevant PPE should be used, and appropriate authorisation should be in place regardless of task location.

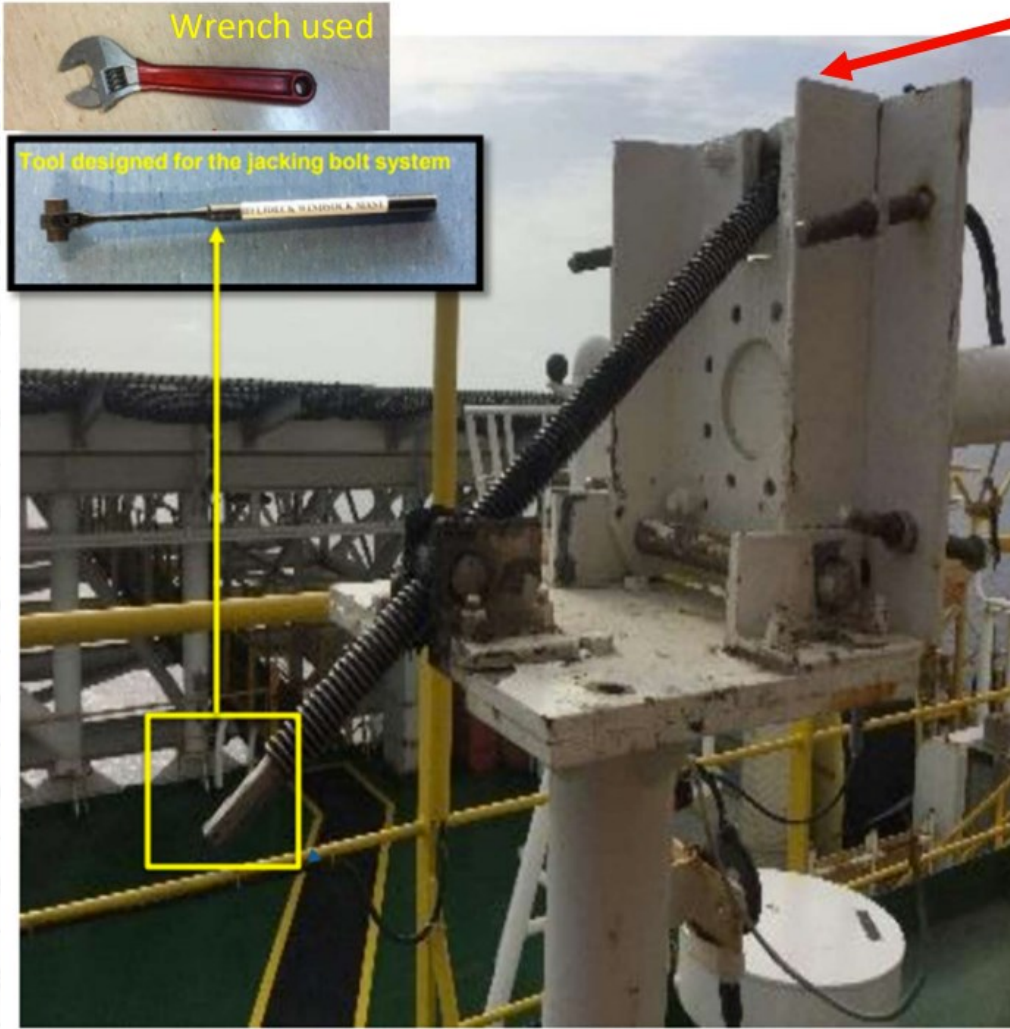
Jacking Mechanism Assembly details

Adequate set-up:  
Washer (1 at bottom, 1 at top) + Castle nut + split pin.
