## BSEE: Exterior Walkway separates from temporary living quarters, putting workers at risk

Safety Flash    Published on 15 April 2026    Generated on 15 April 2026    IMCA SF 07/26

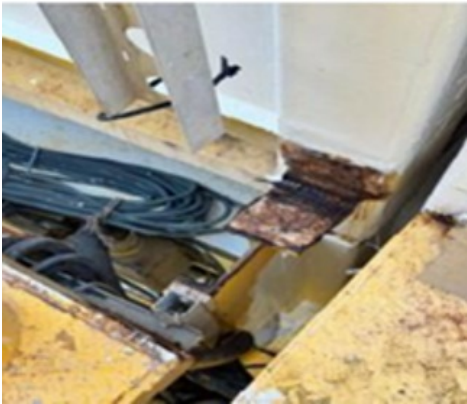
<p><i>Walkway separated outward from temporary living quarters, exposing a significant gap.</i></p>	<p><i>View from below of walkway shifted outward from temporary living quarters, revealing a significant gap.</i></p>

The operator installed the living quarters as a temporary structure designed for removal or dismantling. (The quarters remained in service for 23 years.) As such, the operator's inspections did not account for the structure's age or the offshore environment. Inspection criteria did not address corrosion, fatigue or age-related deterioration of welds.

- Inspections were not adequate: The operator relied on visual inspections only. Those inspections did not verify the condition of the tab welds connecting the walkway to the living quarters.

- Insufficient structural support: The welded tabs at the walkway connection points did not provide enough welded surface for support. The stairway's south side lacked support, which may have increased stress and contributed to the failure.

- Marine environment and aging: Corrosion and age-related fatigue affected the tab welds over time.
- Inspection management weaknesses: The operator used inspection criteria based on the structure's original "temporary" intent. Visual inspections did not identify hazards related to structural support of the living quarters and walkways.

- Design and build "temporary" structures with potential long-term use in mind.
- Update inspection programs for temporary living quarters and similar installations to address marine corrosion, fatigue, weld condition and structural integrity.
- Use non-destructive testing with visual inspections, such as ultrasonic testing, to evaluate weld thickness and detect structural degradation.
