## Cook temporarily trapped in freezer

Safety Flash Published on 3 March 2026 Generated on 3 March 2026 IMCA SF 04/26

A vessel cook was temporarily trapped inside a large walk-in freezer.

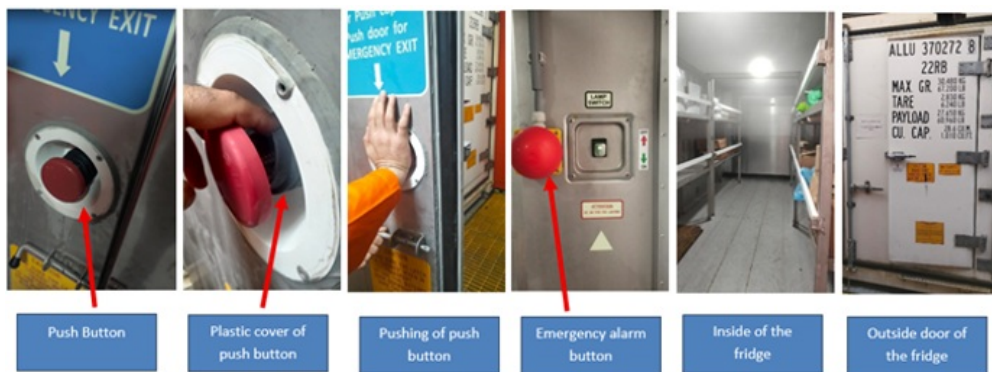
A freezer alarm was received on the bridge, indicating that a person was trapped inside the main deck freezer. Crew responded to the alarm, and it was found that the Chief Cook was inside the freezer and was unable to exit because the internal door-opening push button was blocked. The door was opened from the outside, and the cook exited safely without injury.

- The push button to open the door, did not work: As the freezer is operated at  $-18^{\circ}\text{C}$ , and the door was opened and closed frequently, the significant temperature difference near the door allowed condensation to form and allowed moisture to ingress beneath the rubber cover of the internal push button. This caused the push button to become stuck and inoperable, preventing the door from being opened from the inside.
- It was found that it was common practice to NOT fully secure or close the freezer door whilst inside but to leave it ajar. On the day of the incident, the vessel moved in adverse weather conditions, and the unsecured door closed suddenly, resulting in the cook being trapped inside.

- Amended planned maintenance schedules to ensure weekly hygiene inspections focusing on condensation, ice formation, and functionality of internal release mechanisms and emergency alarm.
- Ensured that the freezer door button spring mechanism was greased to improve functionality and prevent freezing.
- Amended procedures to ensure that
  - A second person was to be notified and present when entering the freezer.
  - Door to freezer to be secured open whilst personnel were inside.
- Further training and raising of awareness was conducted for catering and deck crew.
