Dropped object: falling shim plate while lowering A-frame

Safety Flash Published on 3 March 2026 Generated on 3 March 2026 IMCA SF 04/26

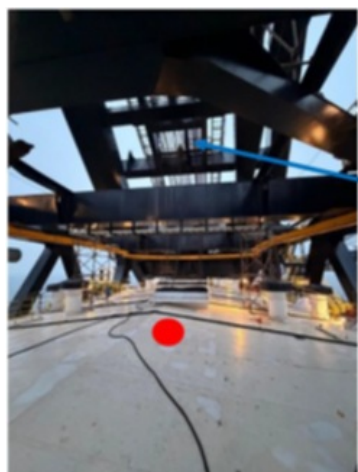
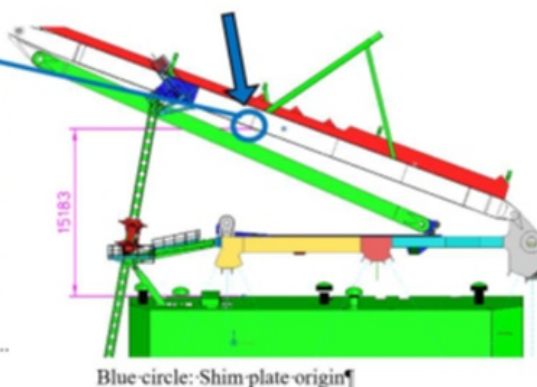
During the lowering of the A-frame of the crane on a large crane vessel, a plate with a weight of 15kg, rolled out from the auxiliary inboard fleeting sheaves.

The shim plate fell 15m onto the roof of the crane cabin. On hearing the noise, work was stopped. The drop zone and surrounding areas were secured to ensure safe conditions. Had the plate hit anyone, there would have been a fatality.

Investigation showed that these plates were not secured at all, and that only by luck, had they not fallen off during previous operations.

- The shim plate had been installed in 2014, when the A-frame did not have the ability to be lowered.
- In 2021 the A-frame had been modified, to have the ability to be lowered.
- During routine maintenance of the fleeting sheaves in 2025, the shim plates were removed and cleaned.
- After the re-installation the shim plates were not secured, as this had never been the case before.
- During previous operations shim plates remained in place by luck.

Further investigation revealed that there was no Failure Mode and Effect Analysis (FMEA), Failure Mode Effect and Criticality Analysis (FMECA) or dropped object study/analyses conducted prior to the lowering of the A-frame.

The investigation concluded that the shim plates did not become dropped objects earlier only because of the accumulation of dirt and corrosion holding them in

There was a thorough inspection of subsequent securing of all shim plates on both crane A-frames.

- Check carefully - could there be other similar components at risk of becoming a dropped object?
- Design review: are there other similar components which might be affected by the increase or decrease of crane inclination angles?
- Consider: the absence of incidents does not necessarily imply a safe work environment.
