## Fall from height during mooring due to rope tension reaction

Safety Flash Published on 13 February 2026 Generated on 17 February 2026 IMCA SF 03/26

Rope became entangled with the propellor during mooring operations of a tanker causing the operator to lose balance and fall onto the lower platform.

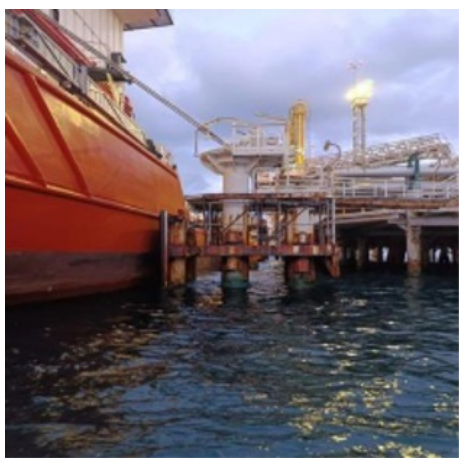
The dolphin platform from astern

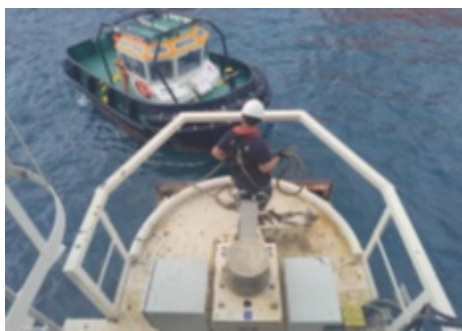
Overhead view of the dolphin platform

- Rope slack was left near the vessel's propeller during mooring.
- Propeller movement created an unexpected load on the mooring line.
- The worker's position (kneeling) reduced stability and escape reaction time.
- The fall protection barrier height (approximately 1.5 m) was insufficient to prevent a fall from kneeling position.
- Communication and coordination between pilot and mooring crew could have been more effective.

- Improve fall-protection design in this context, to cover kneeling positions.
- Reinforced awareness training on safe body positioning and balance during line handling.
