## MAIB: Sinking of tug Biter with loss of two lives

Safety Flash   Published on 24 March 2026   Generated on 31 March 2026   IMCA SF 06:26

The UK Marine Accident Investigation Branch (MAIB) has published Accident Investigation [17/2024](#) relating to the girting and capsizing of tug Biter with the loss of two lives.

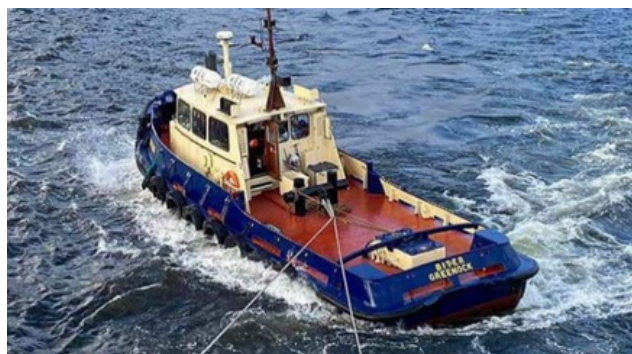
On 24 February 2023, the twin screw conventional tug Biter girted and capsized off Greenock, Scotland while attached to the stern of the passenger vessel Hebridean Princess, which was making its approach to James Watt Dock. Biter's two crew were unable to escape from the capsized vessel and lost their lives.

- The marine pilot's training had not prepared them to work with conventional tugs.
- Master/pilot and pilot/tug exchanges were incomplete and, with no shared understanding of the plan, the passenger vessel's master and the tug masters were unable to challenge the pilot's intentions.
- The passenger vessel's speed placed significant load on the tug's lines and almost certainly caused the gob rope to render.
- The tug's gob rope did not prevent it being girted.
- The tug's rapid capsizing meant the crew had insufficient time to release its towlines.
- An open hatch compromised the tug's watertight integrity and limited the crew's chance of survival.

- MAIB have made recommendations to the owners and to the port involved, including:
  - Review safety management systems and risk assessments to provide clear guidance on:
    - the rigging of the gob rope.
    - the safe speed to conduct key manoeuvres.
  - Adopt a recognised training scheme for tug masters.
  - Commission an independent review of marine pilot training.
