## Two Walk-to-Work gangway incidents

Safety Flash Published on 18 December 2025 Generated on 6 January 2026 IMCA SF 23/25

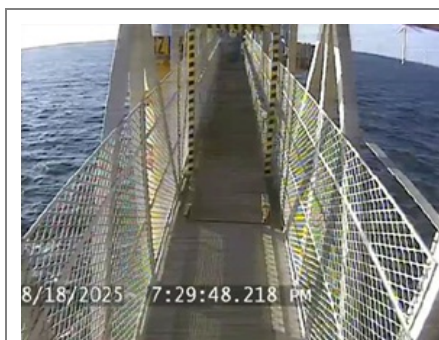
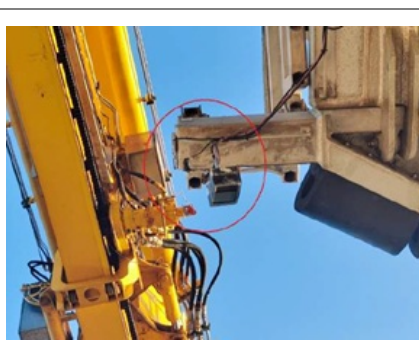
On 18 August, an SOV was engaged in W2W transfers on an Offshore Wind Farm. While initiating the connection with a Transition Piece (TP), the gangway slipped off the TP and slewed uncontrolled to the stern until it collided with the vessel crane. During the slew the operator tried to stop the movement by pressing the emergency stop button without effect. Following the collision the gangway went into auto-retraction mode. All W2W operations were stopped, and the gangway manufacturer was contacted for investigation and damage assessment. There were no injuries. Whilst the crane itself was undamaged, the gangway was damaged. This was considered a high potential incident.

- Equipment failure: The telescopic part of the gangway froze after making contact with the TP. This malfunction caused the tele-tension mode (Bumper Mode) to become active, while the gangway was falsely registered as still being landed. In tele-tension mode the slewing movement of the gangway was in free drift. As a result, solely by gravity and vessel movement the gangway swung in an uncontrolled way astern, colliding with the crane.
- Inadequate barriers: The W2W gangway remained in Bumper Mode, during which the slewing movement of the boom was in free drift. When the gangway passes its operational limits, audible alarms warn the operator. However, as no automatic retraction or physical stop was activated in this case – there was no audible alarm.

The following root causes were identified
- Stiction – "*static friction*" in the hydraulic motor moving the telescopic part of the gangway caused the freezing. In the case where a motor is trying to rotate from a standstill (as it is when it is landed), and when the difference in pressure between the two sides of the motors is too small, it won't overcome that friction.

In order for the motor to operate, a certain pressure difference must be present between both sides of the engine. The manufacturer concluded that at the time of the incident this difference was too low to overcome the stiction of the engine. Therefore, leading to the freezing of the gangway while still being recognized as landed by the system.

- The hydraulic system was modified and then tested extensively alongside in port and then at sea; the identified root cause was reconfirmed and effectively mitigated.
- Other vessels and other operators with similar equipment were notified.
- Clear and unambiguous procedures for operation were developed and put in place.
- Engineered barriers and controls, both hardware and in software, were put in place to prevent this from happening again.
- Cameras were installed to enhance operational oversight and safety.
