Service provider fatality

Safety alert 324

May 2021

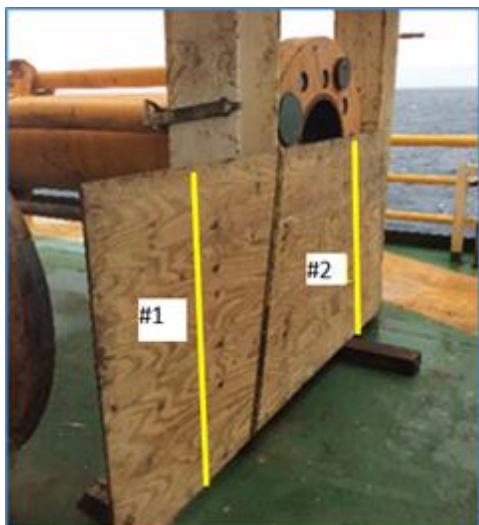
During the inspection, the inspection team leader observed two slings rigged up to a load of 5 metal plates which were stacked vertically, resting on dunnage, and secured to a stanchion by a single 2" ratchet strap (see Figure 1). The slings had been left in place on the plates after they were landed by the crane for efficiency and ease of relocation when needed.

Figure #1: illustration of the position of the plates, using one piece of 4x8 plywood, with the ratchet strap in place and sling position identified

The inspection team leader attempted to, and was successful in, sliding one of the slings from the plates on the inboard side (#1 represented above in Figure #1), but he discovered the second sling (#2 represented above in Figure #1) was pinched between the rear of the plates and the stanchion, preventing it from being taken off on the outboard side. He then called his assistant and requested that he loosen the ratchet strap, presumably to allow for movement of the plates for the pinched sling to be removed for inspection.

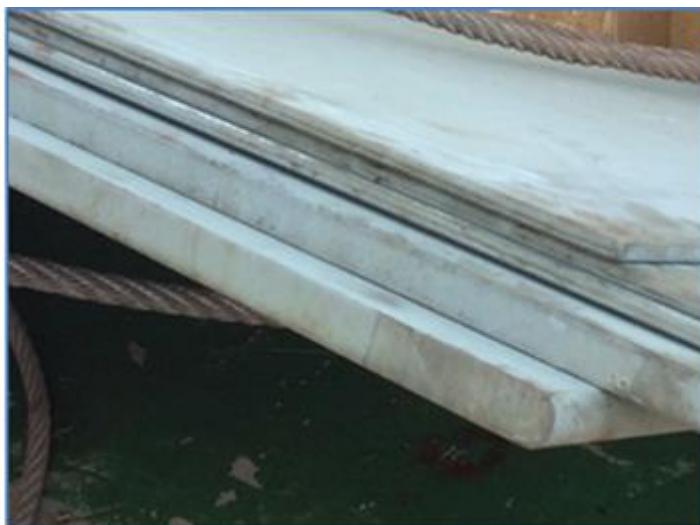
The plates were all 4 x 8 feet; three were 3/8" thickness and the other two were 1" thickness (see Figure 2).

Figure #2: The 5 metal plates, combined weight of approximately 2 T

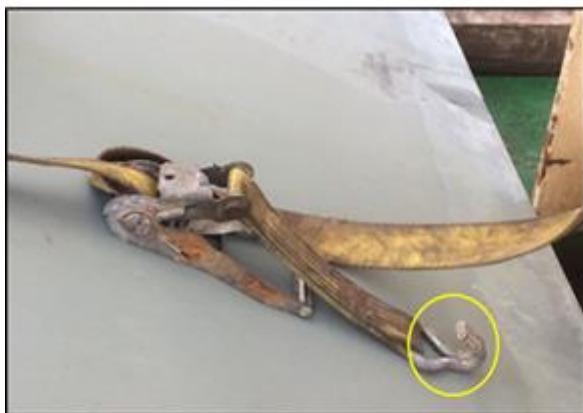
Figure #3: illustration of the ratchet strap hook that came free from the stanchion

- Are there sufficient measures in place to prevent unauthorized manipulation of sea-fastenings? Service provider personnel may not recognize cargo straps as sea fastenings when a rig is in operation. Procedures, including the use of warning tags, should be reviewed to ensure it is clear what needs authorization to release or manipulate

- Review housekeeping and sea-fastening – are materials around the rig stored safely and has the potential for gravitational energy to be released been minimized as far as practical (e.g. if a strap comes loose, will the stored material fall or tip over?) Can this be mitigated by storing in an alternative location or an alternative orientation (e.g. by lying flat)?

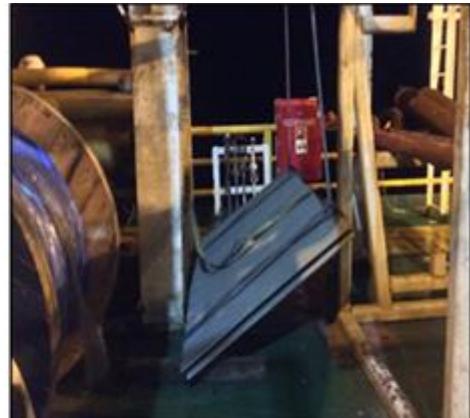
The inspection team leader then leaned his back against the plates; The reason for this is unknown, but it is assumed the intention was to support the plates in their standing position when the ratchet strap was loosened. When he was standing in this position, directly in front of him was a framework for the drilling bail rack. When the ratchet strap was manipulated by the assistant, the hook (ratchet strap) released, (see Figure #3), allowing the plates to free fall forward (away from the stanchion) under their own weight, fatally trapping the inspection team leader between the plates and the framework of the drilling bail rack (see Figure #4).

Figure #4: The position of the inspection team leader

The weight of the falling metal plates, overwhelmed the lead inspector, who was caught in the line of fire and pinned between the plates and the solid frame.

- Inability to identify and manage task deviations, resulting in the original low risk, routine task turning into an unplanned high risk task.
- Worker was in the line of fire with his body placement between a dynamic load and a fixed structure
- Sea Fastening securing load was manipulated

- Line of fire awareness – reinforce with all personnel the importance of avoiding body positioning in the line of fire, including avoiding getting between loads and structures
- Risk perception and stopping the job are essential to working safely
- Ensure tasks are clear and well planned, including pre-job discussion of factors that would necessitate stop work and reinforce the need to stop and re-assess when the task changes. In this incident, a low risk task of visually inspecting loose lifting gear changed to a much higher

risk task without the team recognizing they were deviating from their task – by removing rigged-up slings on sea-fastened cargo, the nature of the task and risk profile changed. It was no longer a low risk task of visually inspecting loose lifting gear at that point
