Dropped V-door - high potential event

Country: *USA - North America*

Incident Date: *8 October 2022 Time: ---*

Safety alert 354**July 2023****IOGP Safety Alerts <https://safetyzone.iogp.org/>****Disclaimer**

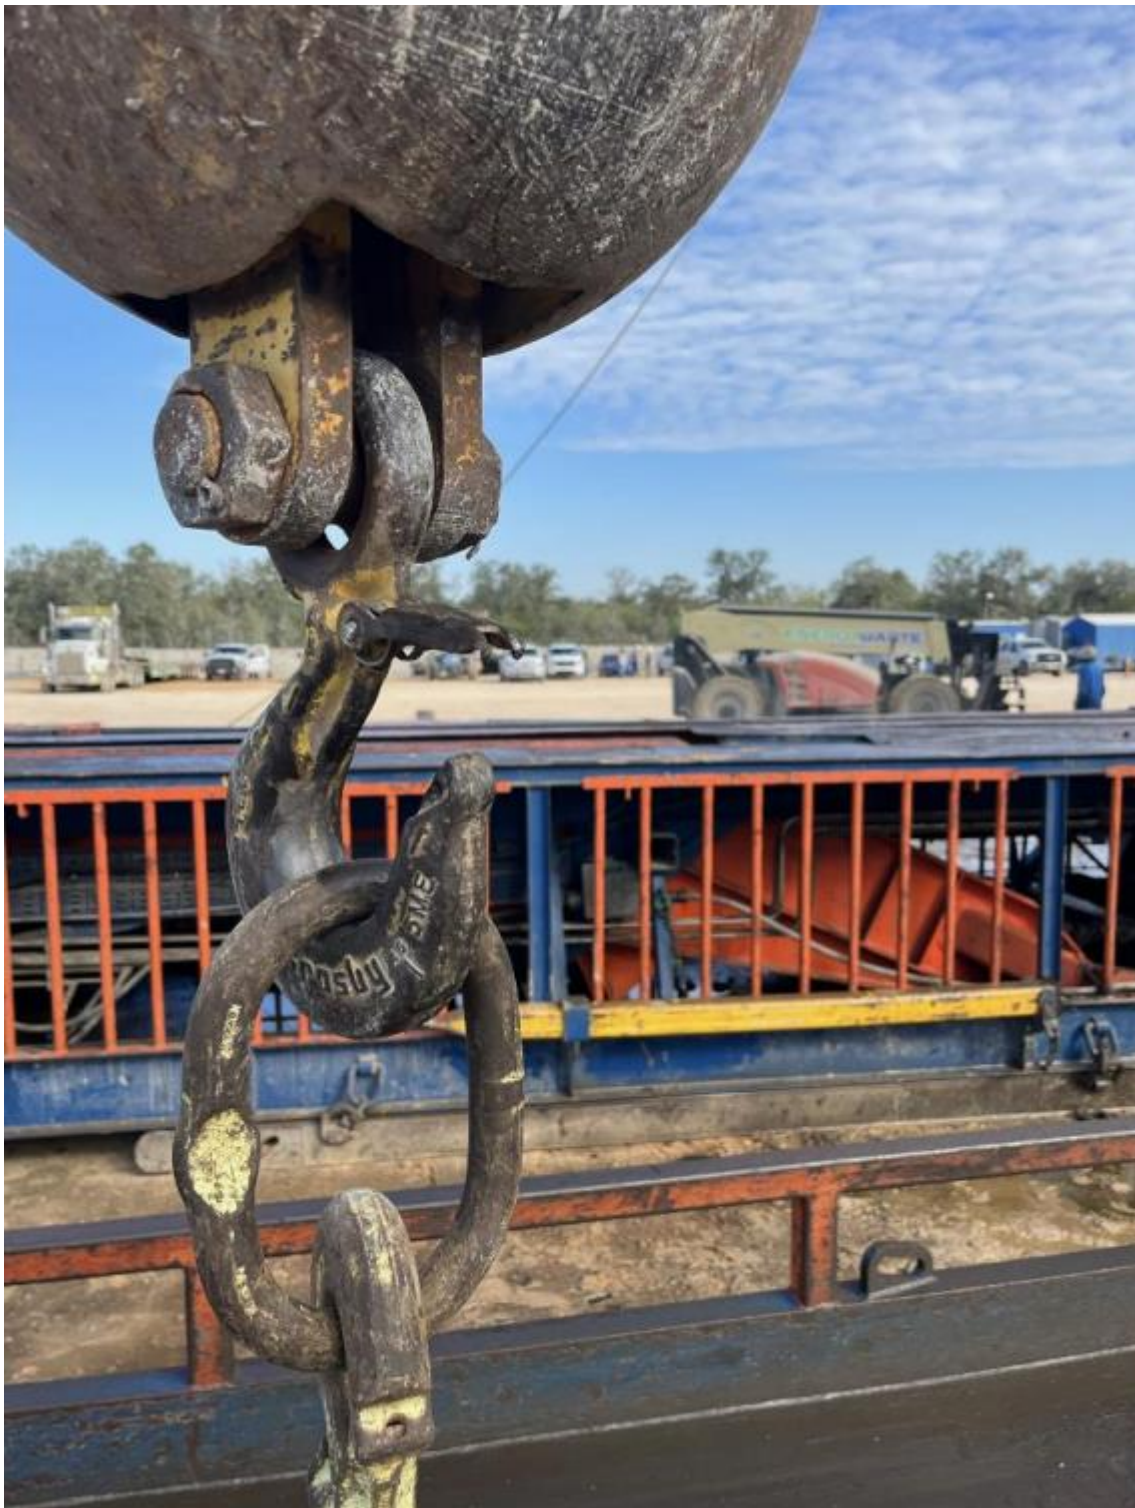
The rig contractor was rigging down from a well, and the logistics contractor was in the process of removing the V-door from the substructure. The lifting equipment was secured, with a tagline attached. Pins securing the V-door to the substructure were removed to allow lifting and removal of the V-door. As the load was being lifted, the crane reversed, and the load levelled. This created a bind in the load, causing one of the D-Rings to dislodge from the lifting hook. The V-door fell (approximately 3 metres) onto the drill line and managed pressure drilling line below.

Figure 1: Lifting hook (open safety latch)

1. Survey of Reiteration of Policy/Procedure Utilization: Management of the contractor reiterated to personnel the existing procedures for Crane lifting operations and confirm personnel understand how to apply these procedures.
2. Equipment Replacement: Contractor personnel replaced the latch on the lifting hook and implemented additional (4 leg chain sling) to avoid improper lifting angles caused by load levelling.
3. Post Incident Toolbox Talk and Sharing Lessons Learned: Shortly following the incident, onsite meeting was held with teams from both company and contractors. Event was discussed in detail

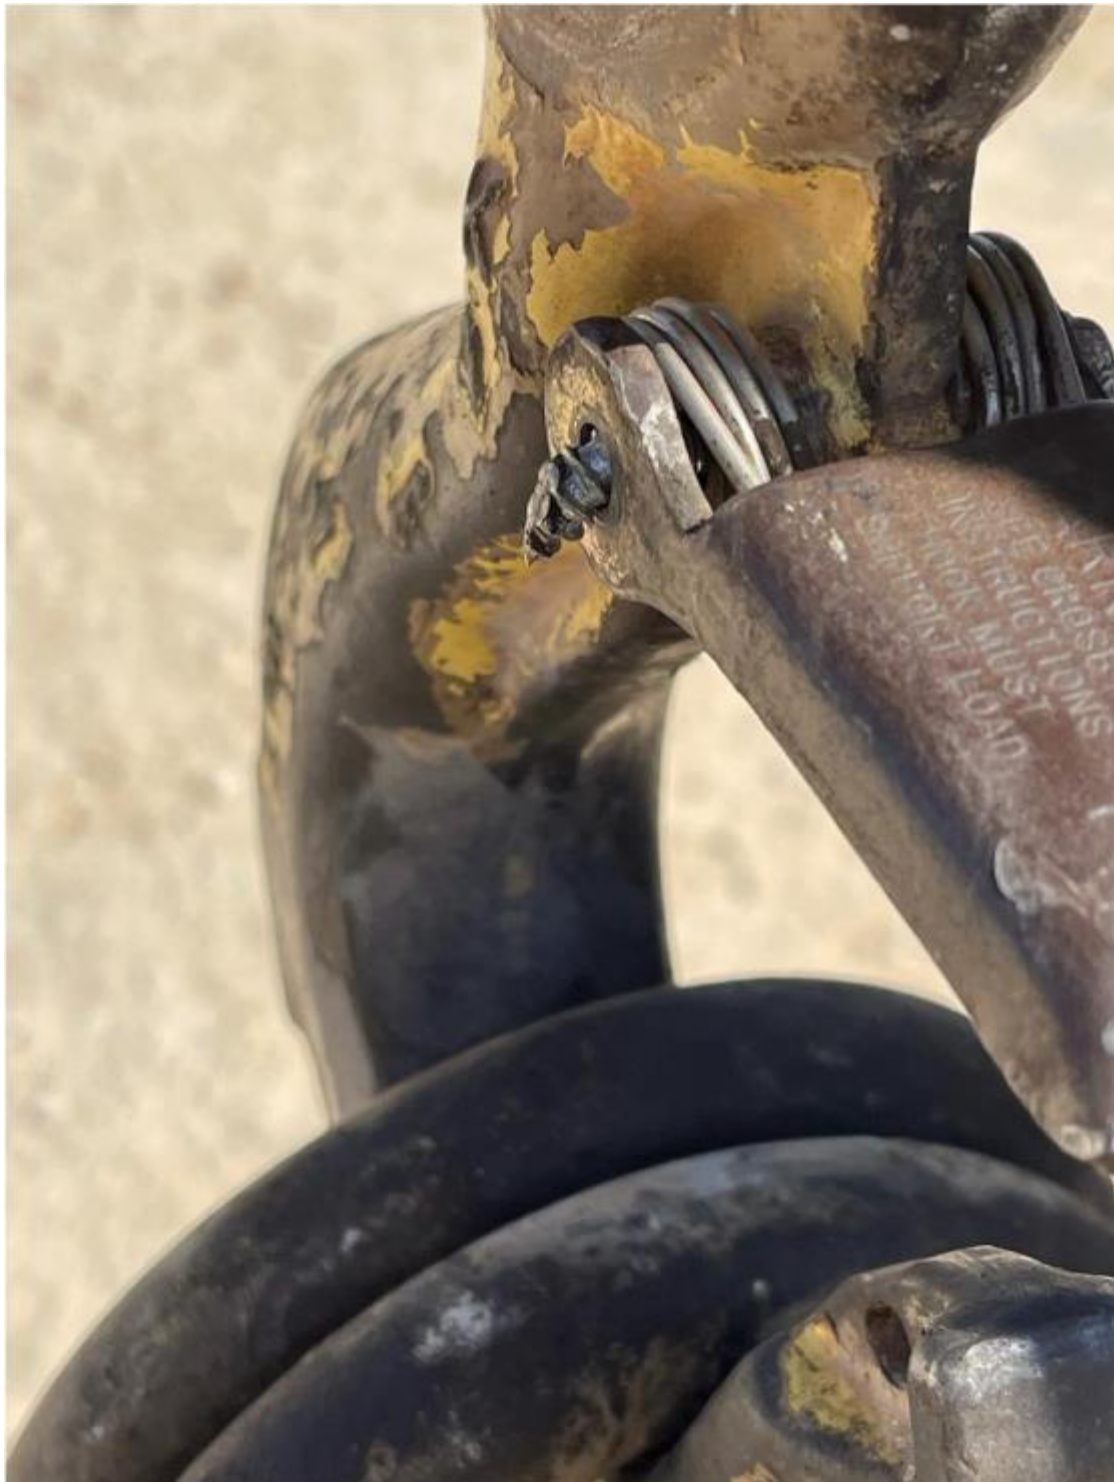
- Supervisory personnel did not ensure crane inspection was conducted prior to the mechanical lift.
- Supervisory personnel did not ensure rigging equipment was adequate for the task.
- Onsite supervision failed to identify and properly manage onsite operational hazards and risks.

Figure 2: Improvised safety latch
