Safety Alert

Number: 26-02

Subject: Daughter Craft Grounding

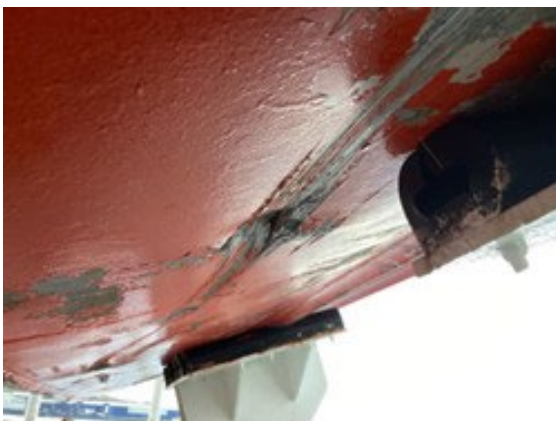
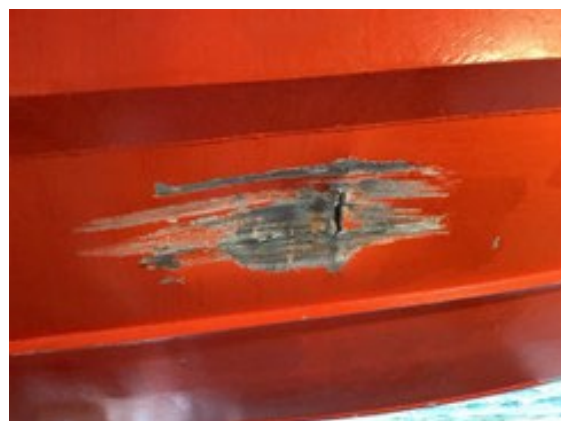
Photographs / Supporting Information

Whilst the DC was in transit it travelled outside the recognised navigational channel, from this, it is suspected that the DC passed over a known navigational hazard outside of the recognised Port navigational channel. This area is clearly identified on the Port Navigational Chart as a drying area (*a region of the seabed that is covered by water at high tide but exposed at low tide*) with an identification and navigational warning light. The result being severe damage to the hull of the daughter craft.

- Poor judgement: Incorrect navigation, electing to operate outside of the recognised Port navigational channel, not following the Port entrance leading lights as per best navigational practice.
- Inadequate initial instruction and planning: No prior passage planning, no waypoints identified therefore we can only assume the hazards have not been Identified. Toolbox Talk did not cover any navigational instructions or information but purely focused on the manual handling element of picking up the mannequins.
- Inadequate monitoring of compliance: As there is no evidence of planning, no formal passage plan or waypoints identified there was no way to evaluate and ensure a safe operation.

- Incident learnings and full accident investigation report to be circulated to the owner's fleet by means of a Safety Alert.
- Vessel Masters to take a "Time out For Safety" to discuss this incident and findings with the vessel crew.
- Vessel Masters to review Safe Navigation documents conducting navigational refresher training for all personnel with a responsibility for safe navigation.
- DC charts to be reviewed, area of operation and local hazards marked and identified, Master to familiarise all with Admiralty products relevant to good navigational practice.
