Safety Alert

Number: 26-03
Subject: FRC Lost at Sea

Published: 16/03/2026

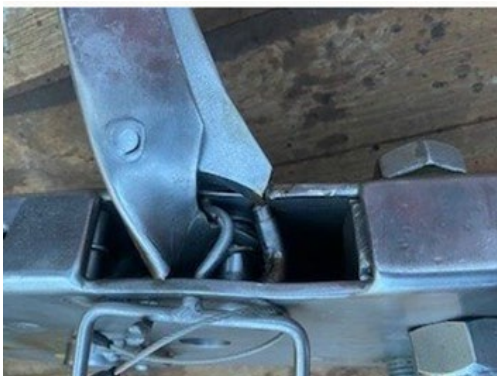
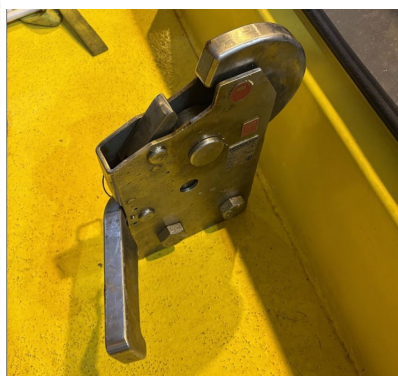
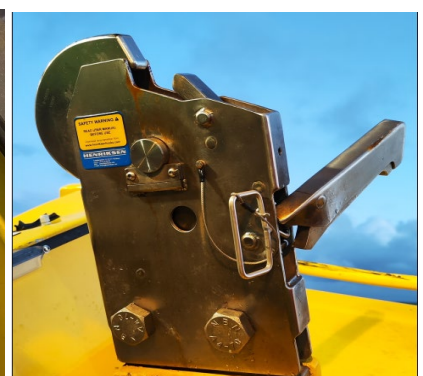
Photographs / Supporting Information

During the onboard investigation it was confirmed that the davit hook and wire were still intact/undamaged, but the fibre lashing straps had been torn apart, and several davit components were damaged.

The FRC was subsequently recovered and an equipment manufacturer report on the Hendriksen type hook show that the arrangement had suffered plastic deformation of the hook body, hook element, and release mechanism consistent with an abnormal high energy impact, resulting in structural deformation. No evidence has been identified to suggest malfunction, wear-related failure, or spontaneous release under normal operating conditions.

A large, unexpected wave hit the vessel from abeam. The wave forced the FRC upwards, impacting the davit with such a force that it severely damaged the hook release mechanism. The lashing straps for the FRC (2,5 t) were under-dimensioned and worn out (5 years old).

Enhanced inspection of the FRC stowage and securing arrangements during weekly inspections, and when adverse weather is expected. Additional lashings may be applied in advance of forecast heavy weather.

Periodic planned maintenance check of FRC lashing/ratchet straps (using 5t lashings), and planned maintenance routine to replace FRC lashings at 2-year intervals.
