High Value Learning

Chemical Tank Lifting Bridle Master link Failure

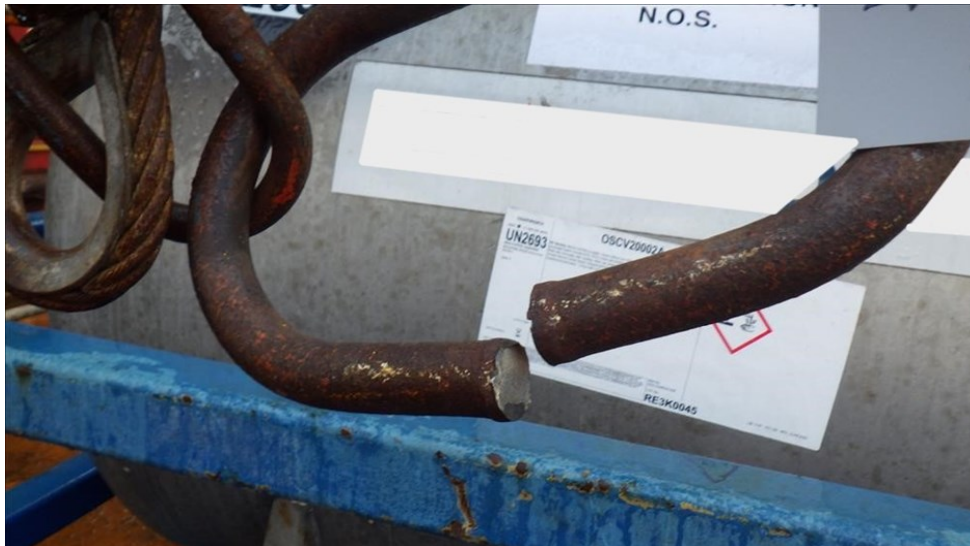
During cargo handling operations there was a requirement to move a full tank of chemicals weighing 4.7t to a decanting area. The crane pennant was attached to the master link of the tank lifting bridle and the crane operator began taking the weight. Whilst the crane was taking the weight the master link parted at the weld resulting in the crane pennant load hook becoming detached from the load.

The tank did not leave the deck at any point as the full weight had not been taken by the crane (3te was indicated by the Crane MIPEG at the time of failure).

The metallurgical examinations have now been completed, unfortunately in the case of the failed master link it has not been possible to positively identify the causation of the failure. The fracture face showed some evidence that it was a fatigue failure with the crack progressively making its way into the link until the eventual ductile fracture of the remaining material. The link had been manufactured in 2015 and had been in service for nearly 8 years, its last NDE was undertaken 42 months prior to the failure (the DNV Standard recommends NDE at intervals not exceeding 48 months).

- The precautionary approach of advising industry to consider adopting a six monthly MPI of all chemical tank (tote tank) lifting bridle master links & sub link assemblies no longer needs to be adopted.

- The available evidence suggests that the Master Link was correctly manufactured, inspected and tested in accordance with the applicable DNV standard and was considered to be suitable for service up to the time of failure. The link which failed had been in service for nearly eight years and failed 42 months after its last 48-month MPI. It is reasonable to conclude the crack had developed and progressed significantly during this 42-month period. Consideration should therefore be given to reducing the periods between MPI examinations for master links which have been in service for more than 4 years, and the subsequent frequency increased from 48 months to 24 months.

- When indications are found during the MPI they must be examined and if they are found to be cracks they must be dressed out by following the original manufacturer's guidance. When found it would be useful if Inspection Companies would record the type of container to which the master link is fitted to determine whether such cracks are more prevalent on a particular type of container.
