## 1 Compressed air rather than oxygen supplied to divers

## 2 Failure of proportional valve in saturation chamber control

## 3 Case study: saturation diver fatality due to hydrogen sulphide

## 4 Case study: confined space fatalities due to Hydrogen Sulphide

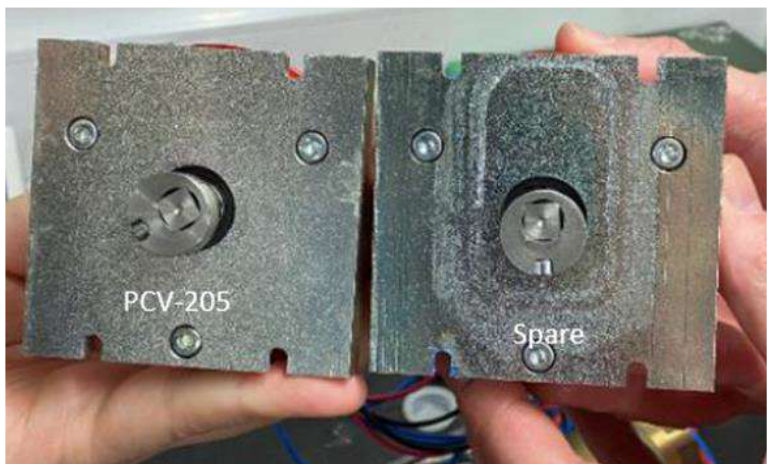
- The valve feedback did not respond correctly, the potentiometer was found slightly defective;
- The diving contractor’s personnel had dismantled the valve (although this was expressly prohibited by the manufacturer) in an attempt to solve the problem, and had reassembled it 180° upside down. This made it impossible to understand if the potentiometer was damaged by wear of time or by wrong disassembly/assembly;
- Critical spare parts for the saturation system were not held on the vessel;
- Investigation found debris in the valve seat, which could have led to more serious problems (see second image).

- Share incident with operators of similar saturation systems equipped with that specific equipment;
- Ensure there is a stock of spares considered critical by the saturation system supplier;
- Amend planned maintenance system to include appropriate testing, maintenance or planned replacement of critical parts;

- Checking pipe cleaning status and filtering throughout the system;
- Ship all dismantled valves to the manufacturer for further examination;
- Perform appropriate tests before returning to dive operations.

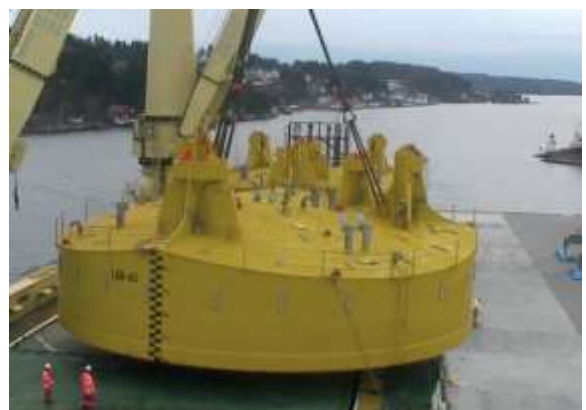
*Jack-up rig leg "spud can" removed for maintenance*

- Cause of death as determined by the Coroner as asphyxia. Circumstantial evidence pointed to inhalation of H<sub>2</sub>S anticipated in the spud can. Spud can is almost 5 m in height and because of its typical internal construction, has numerous poorly ventilated nooks and corners;

- In addition, there were puddles of mud sludge which contain dissolved H<sub>2</sub>S. The first person who went inside the spud can stirred up the collected H<sub>2</sub>S in low areas and also the sludge containing dissolved H<sub>2</sub>S. Being exposed to this, he became unconscious and collapsed;

- Proper planning and appropriate training for enclosed/confined space entry, particularly for third-party contractors;
- Such training should include:
  - Active monitoring for H<sub>2</sub>S gas, including both personal and area monitoring;
  - Understanding of the dangers of H<sub>2</sub>S and how it behaves;
  - Where to wear personal detection monitors, preferably over the chest pocket or on the collar, i.e. as close as possible to the nose;
  - Proper use of correct breathing apparatus;
  - Use of the “buddy” system;
  - Training and drilling of emergency response team;
  - Proper use of Permit to Work system and safe systems of work;
