## High Potential Near Miss: Dropped object due to contact with crane sheave

Safety Flash Published on 14 May 2026 Generated on 14 May 2026 IMCA SF 09/26

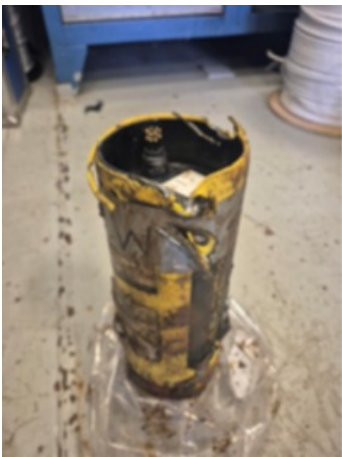
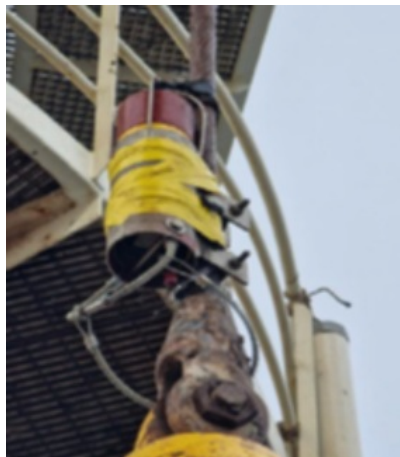
During crane operations on a vessel operating in deep water, the whip line was retrieved from approximately 2,200 meters depth to lift and deploy a hang-off sling over the vessel's side. While lifting the sling from the deck, a Dynamic Positioning (DP) beacon (a subsea positioning aid mounted on the crane wire just above the hook socket) came into contact with the sheave protection bars. This resulted in the beacon and its holder assembly detaching and falling to the deck below.

The DP beacon weighed 4.3kg and fell 30m to the deck below. No personnel were in the immediate vicinity at the time of the incident; however, no direct controls were in place to restrict personnel access to the area. An investigation is ongoing.

Beacon fitted to crane hook

- The DP beacon and clamp were fitted directly to the whip line wire rather than to the swivel/block, creating an inherent risk of snagging or clash.
- There was no secondary retention attached to the DP beacon/clamp arrangement.
- Management of Change (MoC) had not been considered before attaching the beacon to the crane wire.
- This process may have required resetting the relevant crane limits to prevent any clash or contact.
- The lifting team did not adequately monitor the beacon's position relative to the crane sheave during lifting operations.
- Although the scope was managed by our member, the equipment and personnel involved were not directly under our members' control.

- Can we ensure that similar beacon attachment mechanisms do not compromise equipment safety?
- Ensure that dropped object surveys and awareness programs do actually reflect the current condition of all equipment at the worksite.
- Check crane settings and limits are correct, particularly following deep-water deployments.
- When dealing with third-party contract workers and equipment, ensure there is a clear understanding of equipment limitations and conditions.
