## Description of incident:

A team of Scaffolders were tasked with the dismantling of a 4 week old scaffold structure.

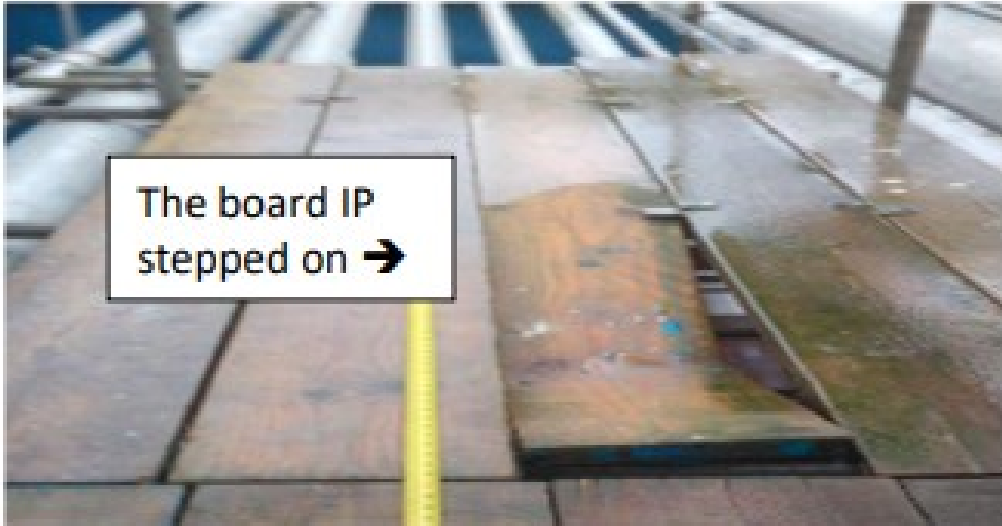
The board IP stepped on →

The IP then moved back on the platform, stepping onto one of the scaffold boards. At this moment, the scaffold board snapped in half. Both ends of the board stopped on a pipe that was directly underneath, so that the IP's leg did not fall through. However, as a result of the impact, the IP hurt his knee. This caused the IP to be unable to perform his duties and resulted in days away from work.

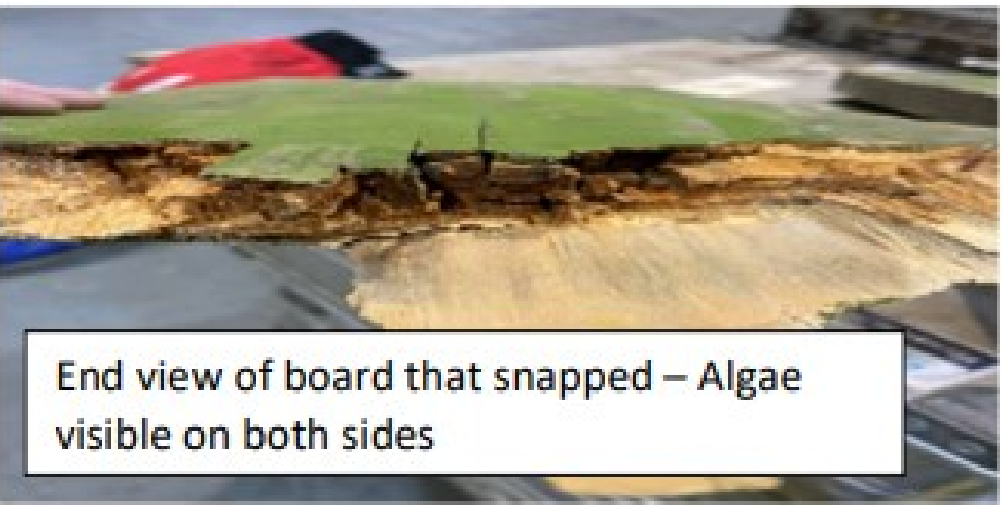
End view of board that snapped – Algae visible on both sides

- The scaffold board was contaminated with green algae, which is an indicator of the poor quality of the board; it was also much lighter than a standard board.
- The scaffold involved in the incident was erected 4 weeks before dismantling took place, all boards and fittings were checked prior to the installation. The green algae was identified, however, because it was seen mainly as a factor that increases the potential for a slip, the board was only turned to the side that was less green and included in the erection. The same team that were dismantling it, assembled it.
- Scaffolding Procedure and quality documents were not adhered to when completing a pre-use check of the boards used for erection of the scaffold.
- The scaffold was subject to weekly inspections, during which no defects were detected.
