Description of incident:

A technician identified flashing/arcing on heat tracing tape, attached to a process line, close to where they were working.

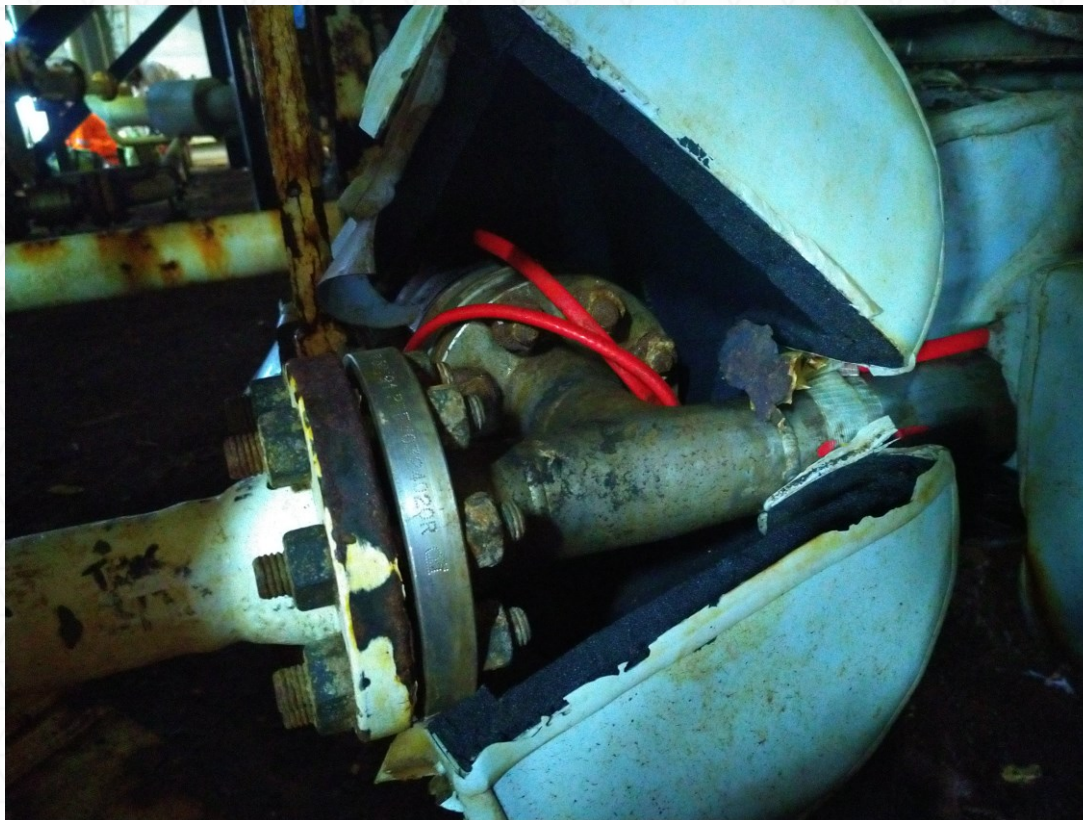
The heat tracing tape had not been covered by pipe insulation for a period of time meaning that it had been exposed to the elements and free to move. The tape eventually became damaged by fretting. This then led to the tape arcing, which is an ignition source in a hydrocarbon process area.

- Pipe insulation must only be removed or reinstated by authorised personnel – if you need to carry out a task and it is covered by pipe insulation, do not just remove it yourself.
- When authorised personnel remove pipe insulation, the heat trace tape will also be isolated.
- If pipe insulation is found to have been removed, raise an Observation Card to ensure it is replaced and check the isolation status of any exposed trace heat tape.
