Description of incident:

Two High Potential incidents were recorded in 2022 due to the fall of lifting trolleys from their runway beams.

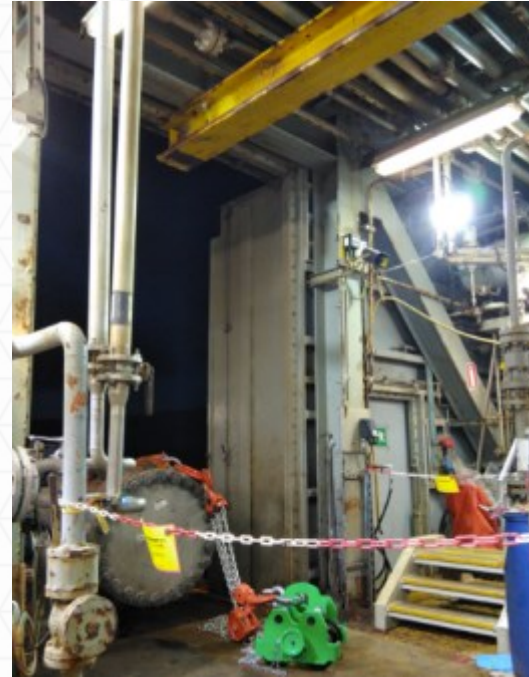
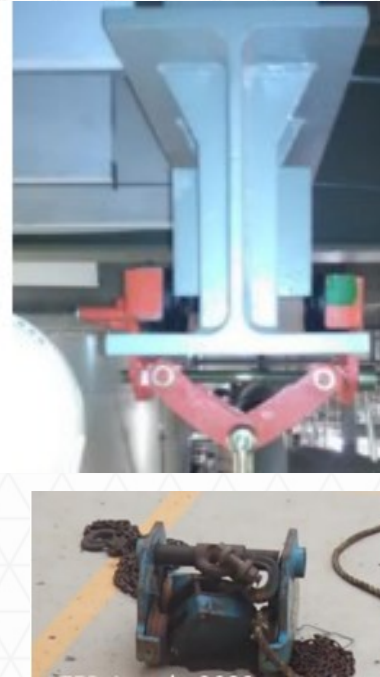
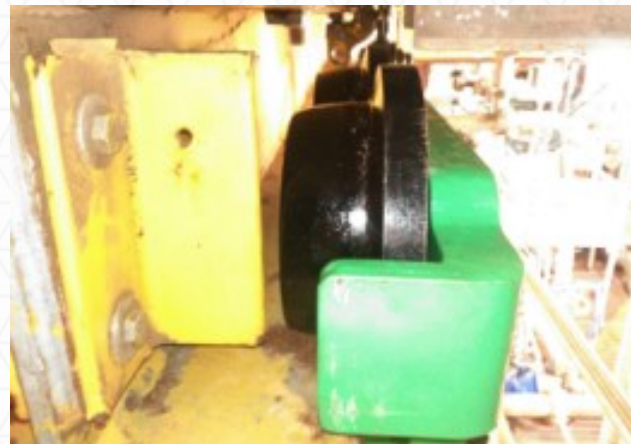
- The lifting trolley beam (weight 172 kg) together with the chain block (weight 64 kg) slid from the runway beam and fell on the deck, 4.7 m below. No persons injured
- The monorail beam trolley (84Kg) overran the endstop and fell (5m). No person injured

For all cases, the runway beam end-stops failed to prevent the hoist trolleys running off the end of the beam:

- a) the end-stops were undersized for the beam / trolley width, or
- b) the manual hoist trolleys were oversized for the beam used.

Beam stoppers are usually designed for defined type of trolleys (Ref. manufacturer guide). When changing the type of trolley, there is a risk that the end-stop is not correctly sized for the trolley in use.

- Perform a survey of the runway beams to detect end-stops that do not extend to the edge of the beam. Beams fitted without end stops or fitted with unadequate end stoppers shall not be used and shall be marked accordingly onsite. Implement modifications of the stops where required so that they fit all type of trolley.

- The monorail on which the trolley is installed shall be checked, inspected and certified. Ensure that scheduled inspections of fixed lifting equipment include a verification of beam range and end-stops. Visual structural checks of the hanging trolley beam shall be done looking for deformation of the flanges and missing anchoring bolts.

- Ensure that the trolley is fit for the beam and properly installed according to the manufacturer instructions. Trolley drops may also result from an inappropriate beam width whereby a limited part of the wheels of the trolley is rolling on the beam. Indication of beam range is marked on the trolley.

- In all cases, ensure that the functional test including end stop effectiveness is carried out after each trolley installation. Include this test within the site procedures i.e. the lifting plans, permit to work. Do not release trolley for use without confirmation of end stop function.
