Description of incident:

A supply vessel was travelling back to port after receiving operational equipment from an offshore platform.

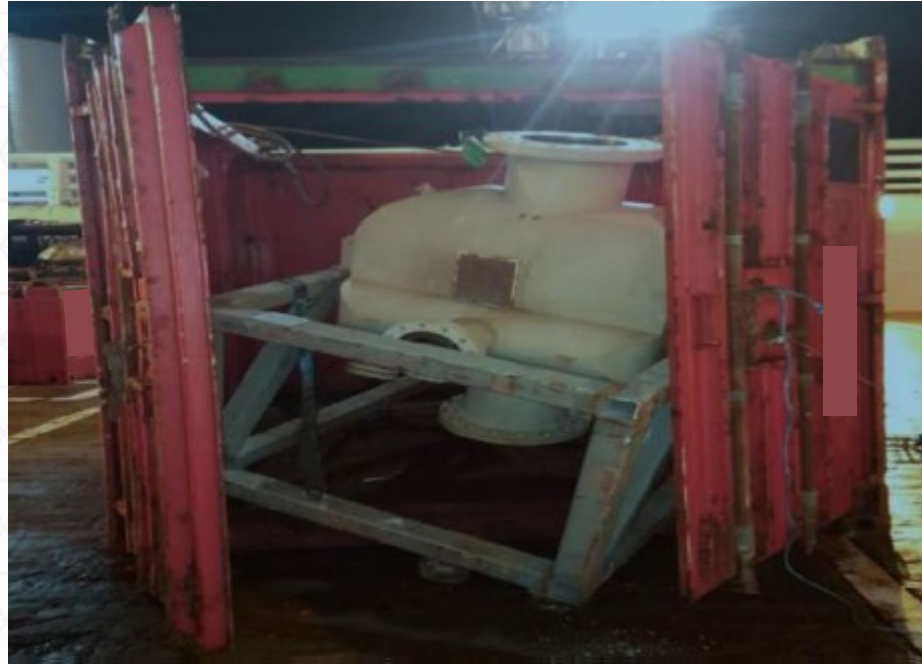
While travelling back to port numerous loud bangs were heard coming from the main deck. Upon further investigation, it was discovered that the doors to the container carrying the wheeled base cooler frame had burst open due to the load inside being unsecured.

- Wheeled frame may have been used; however, had no dunnage and, without dunnage, was unsuitable for transit with wheels in contact with the container floor.
- There was a communication breakdown on the correct backloading process to be followed.
- There were an insufficient number of ratchet straps utilised.
- Tarpaulin was available to cover the cooler but not utilised. Covering would mitigate possible snagging of the container bridle on the coolers flanges during lifting operations.

- Time out for Safety held and refresher on the correct method to backload equipment was completed.
- Coaching sessions were arranged for those involved with the incident.
- A review of training and competency requirements related to cargo backloading was undertaken.
