# Safety Alert

**Number: 23-01**

**Subject: Tubular Load Strikes Vessel Light**

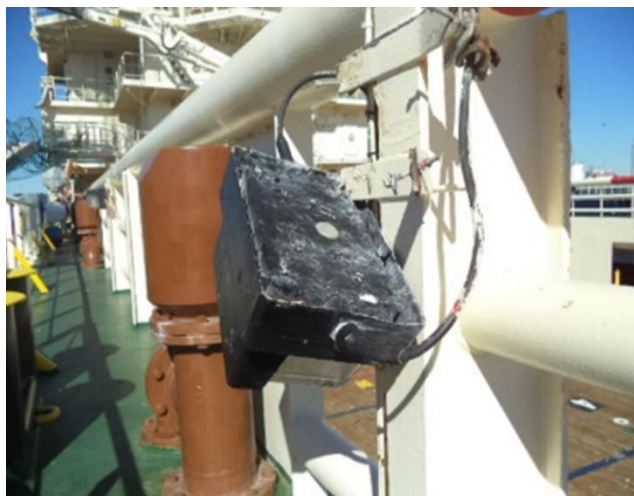
While transferring tubulars from one trailer to another using an onshore crane, the operator lost control of the load and was advised to land the swinging load onto the deck of vessel. In the process of doing this, the load struck one of the vessel lights damaging the bracket.

- The crane operator slewed the load over the indicated landing area however the momentum had increased, and the load started to swing. The load then gathered further momentum making it impossible for the crane operator to rectify
- The boat foreman who was below the bridge of the vessel made the decision to land the load on the deck of the vessel due to the possibility of one of the joints slipping from the slings. While lowering the load to the vessel deck the joints swung through the bull rails damaging the vessel light
- Slings were incorrectly applied (offshore) with a combination of being too long and choked towards the center allowing little tension on the sling
- The weight of the load was 800kg against a hook block weight of 2200kg making it difficult for the crane driver to control the load

- The two joints should have been shipped in a basket - loose joints should not be bundled as a pair and especially with the length variations (Bundled joints should always be odd number)
- Lifting operations must always be compliant with company lifting procedures. Any deviations require a deviation or management of change request
- A memo was sent to all of the members sites regarding the importance of communications during lifting operations
- Liaise with offshore teams regarding condition of backloaded tubulars. Instruction to be given to all quayside teams to report any tubular handling which is inconsistent with current good practice
- Reflective learning session held to discuss the 'Swiss Cheese' model effect with quayside team, focus on key trigger points missed when 'Stop the Job' should have been implemented
- Camera to be fitted to crane booms to support vision of crane driver
