Collapse of false ceiling - service station shop

SAFETY ALERT

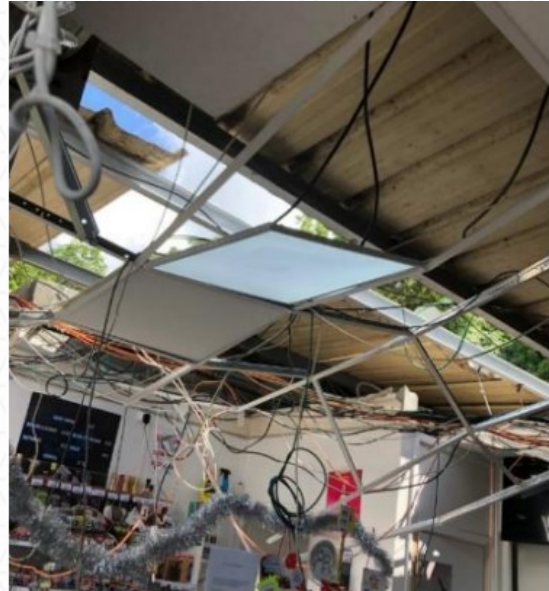
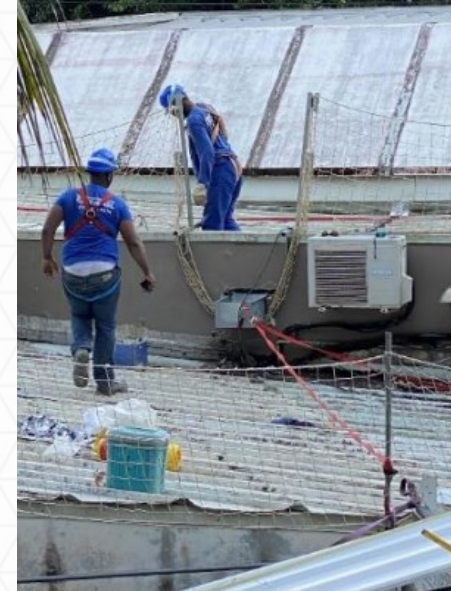
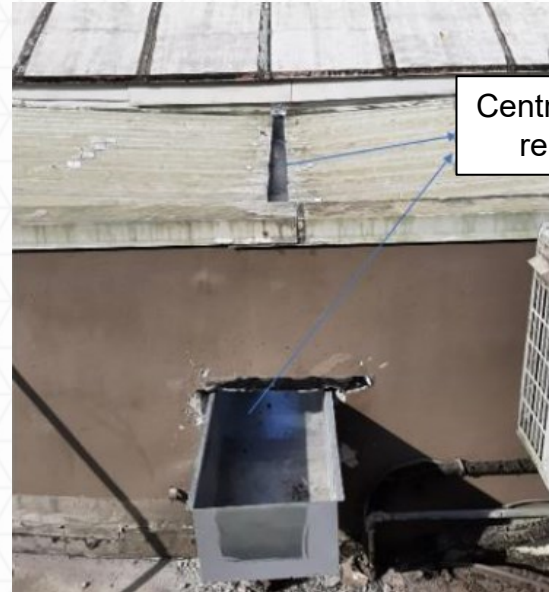
4 workers from an external contractor company were performing work to replace the roof gutter of a store. These workers were positioned on the roof wearing harnesses and lifelines. They pulled the central gutter in order to remove it. This motion affected the structure of the false ceiling, resulting in the fall of some elements of the structure and plates of the false ceiling.

Central gutters replaced

The analysis of the event concluded that the fixing rods of the false ceiling structure had remained attached to the gutter despite the observation made during the preliminary site visit.

This visit, part of the preparation phase, was conducted by 2 individuals (service station manager + External company supervisor) without a representative of the subsidiary. Some of the anchored fixing rods were not removed before starting the removal of the gutter: their identification being difficult because of the configuration, the construction, and the difficulty of visual detection. The extraction of the gutter led to the tearing off of a part of the structure and then, the collapse of the false ceiling of the store.

- Work at height: Carry out an inspection of the site to check the work area and access before the risk analysis (check, as far as possible, the areas under/on the roof (inside/outside the building)).
- Carry out a complete risk analysis with the External Company (take into consideration the risks of electrical lines).
- Ensure that the External Company has defined an operating procedure and a risk analysis known to its operators and in compliance with the Company's requirements.
