Dropped Object from Crane Boom Rest

SAFETY ALERT

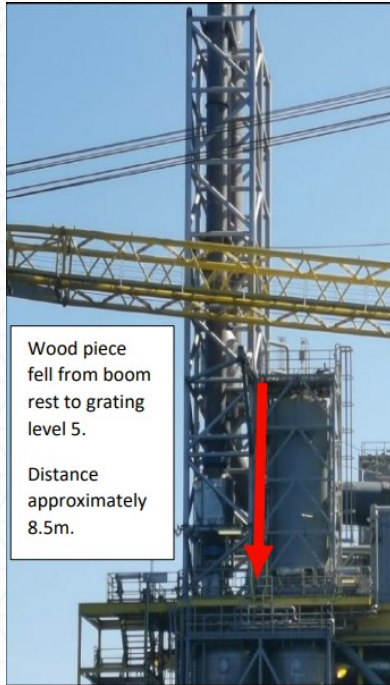
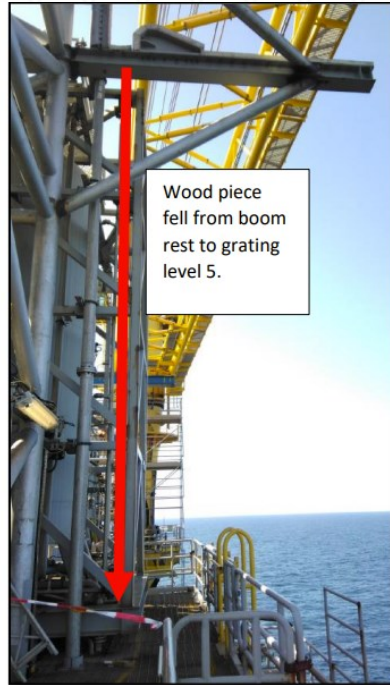
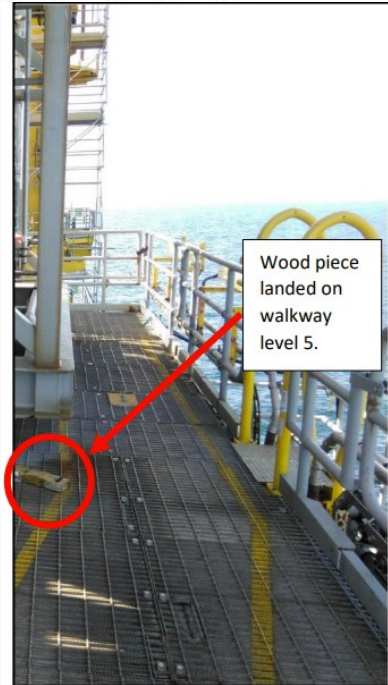
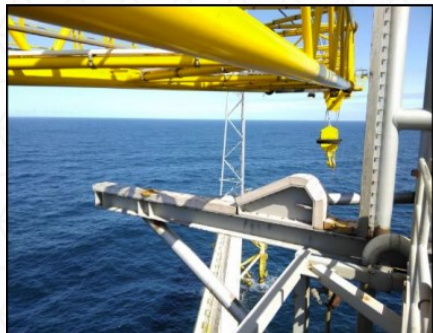
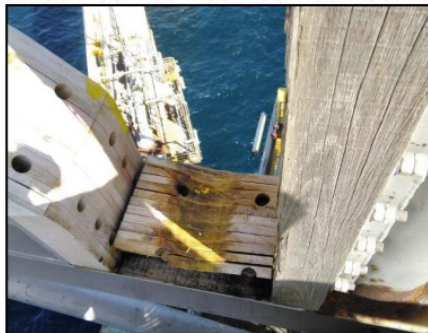
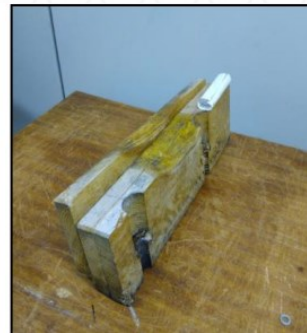
Whilst carrying out area checks, the Deck Lead identified that a piece of wood from the crane boom rest had fallen 8.5 meters to the level 5 deck. The dropped object weighed 1.8Kg.

The dropped object landed just beside the walkway, and separated into two pieces upon hitting the grating (1.25Kg & 0.55Kg).

- The design of the timber cradle block in the new boom rest (glued, laminated timber without lateral mechanical restraint) did not offer adequate physical integrity to withstand repetitive, dynamic loads associated with normal crane usage.

- Ensure that the design of new Crane Boom rest blocks are fit-for-purpose, and that their means of retention provide adequate integrity to withstand repetitive, dynamic loads expected of crane usage.
- Ensure that newly designed, or retrofitted crane boom rest blocks have the lowest number of component parts practicable, and avoid use of laminated blocks wherever possible.
- Ensure that crane boom inspections identify, and pay particular attention to the integrity and security of any boom rest blocks of laminated construction (consider their replacement and/or secondary retention measures where necessary)
- Ensure that the 'request for modification' (RFM) process is followed for all field modification projects, ensuring that adequate hazard analysis is performed for all new and/or revised designs/modifications.
