Dropped object due to over-ridden limit switch

Safety Flash Published on 2 October 2025 Generated on 13 October 2025 IMCA SF 18/25

A limit switch on a crane was over-ridden, resulting in wires parting and objects falling from the crane.

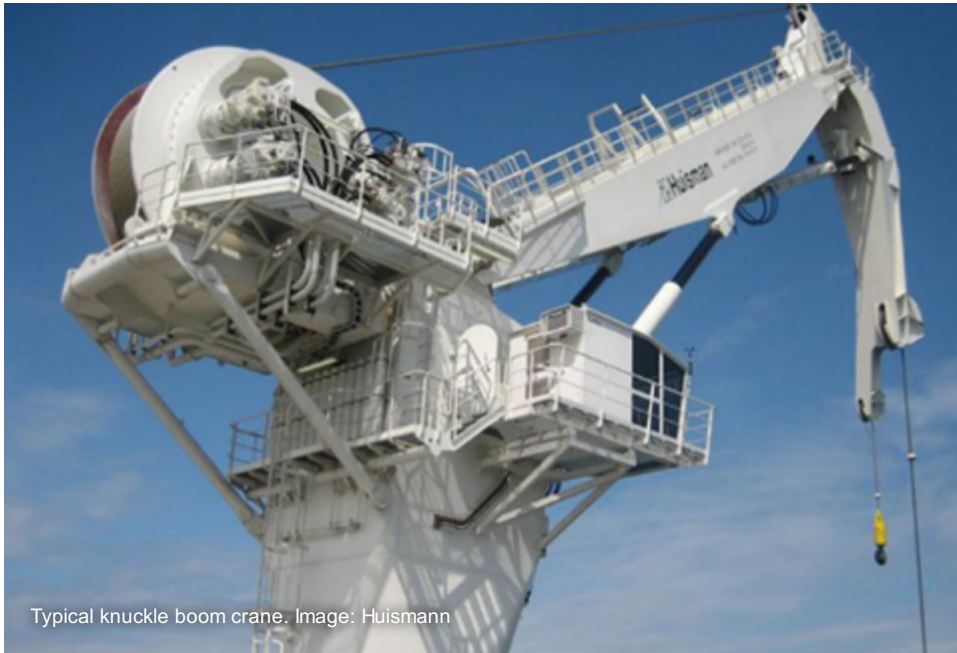
Typical knuckle boom crane. Image: Huismann
