Finger Fracture During Manual Handling

SAFETY ALERT

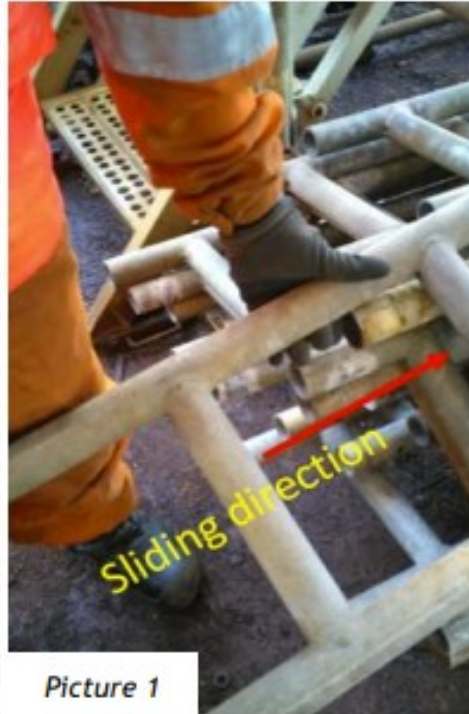
After being passed down a 4-metre ladder beam, the Injured Party (IP) carried the beam to the storage area then went to position the ladder beam into a scaffold rack. As the IP attempted to slide the ladder beam into the scaffold rack (picture 1), his left hand became caught between the ladder beam he was holding, and another ladder beam already situated in the rack (picture 2).

Review existing risk assessments and ensure suitable and sufficient controls are documented with regards to the manual handling of both general scaffolding and long-term/aged scaffolding.

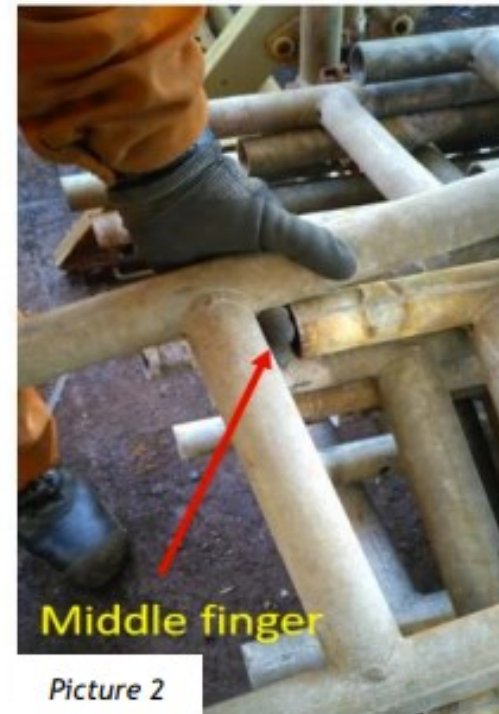
This resulted in the IP suffering a significant injury to the middle finger of his left hand resulting in the need for surgical intervention to repair the top of the finger.
