Fork fractured whilst forklift in operation

SAFETY ALERT

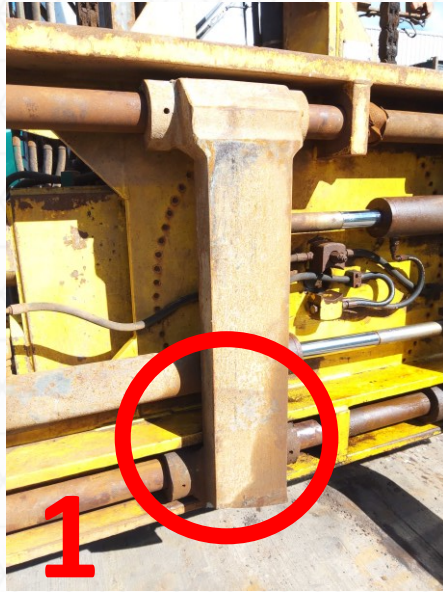
- A forklift operator was rotating a fully loaded skip when the right-hand fork fractured just below the lower fork mounting Boss.
- The load was set down on the ground with no further incident

- LOLER inspection was in date and daily check completed prior to incident
- The right-hand fork fractured immediately below the lower mounting boss support (image 1)
- The left-hand fork was removed, cleaned and inspected – the lower mounting boss was found to be cracked (images 2 & 3) in a similar area to the right-hand fork
- Both forks appear to have suffered from fatigue fractures across the lower mounting boss causing the complete fracture of the right-hand fork
- Overloading is not considered a contributing factor in this incident

- A schedule of MPI crack testing to be adopted, - carried out every 6 months alongside the LOLER checks already being undertaken.

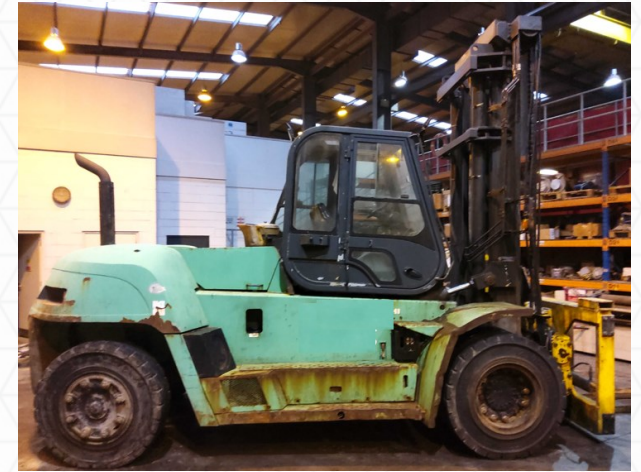
Truck details:

- Mitsubishi FD160N
- Truck fitted with SMC Euroclamp U180RLE Rotator
