High Value Learning

Brittle failure of valve body bolting on double block and bleed (DBB) valves

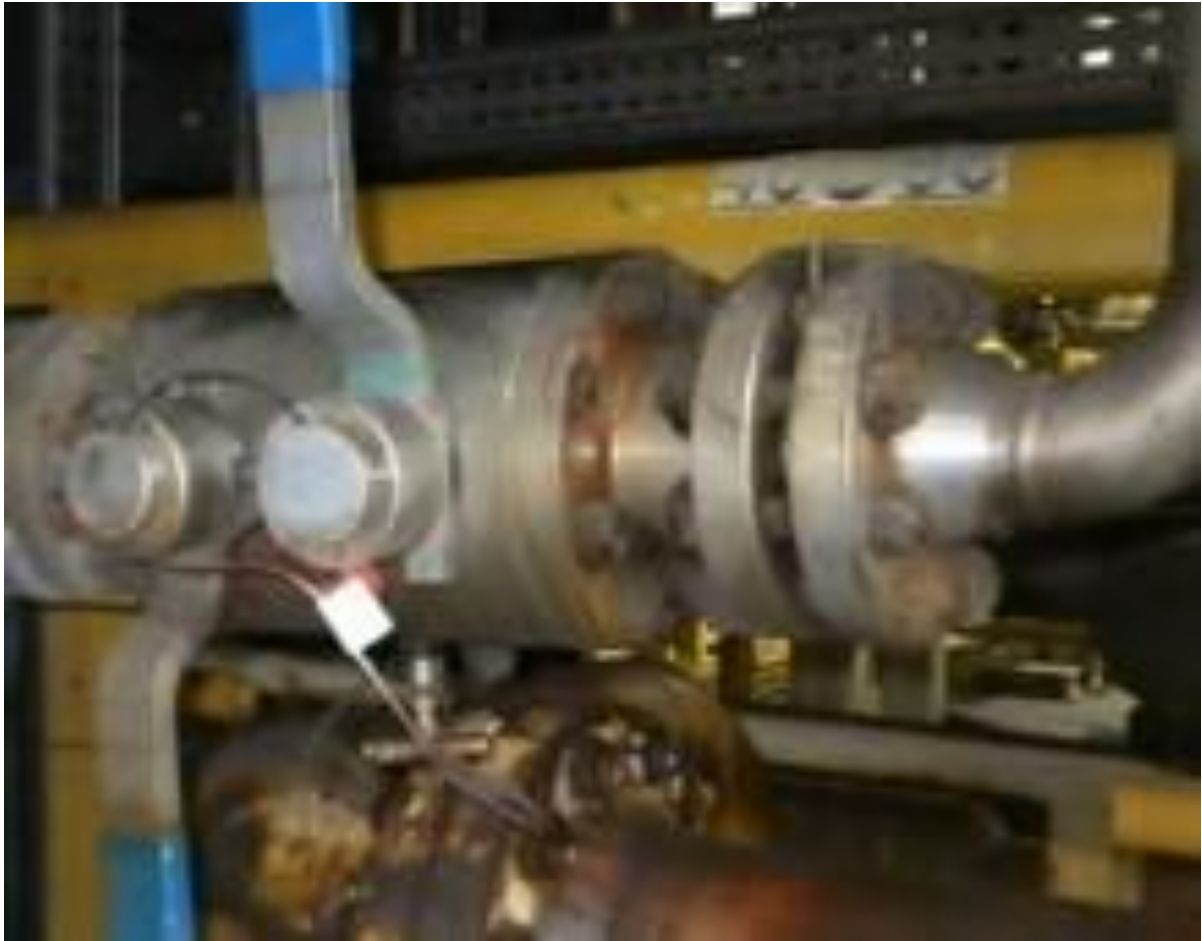
A UKCS asset has revealed multiple brittle fracture failures to the body bolting on Dublok DBB valves since 2023.

None of the failures to date have resulted in process release due to the remaining bolting providing sufficient redundancy in body integrity. Had the bolting failures exceeded the available redundancy, then there is the potential for the valve body to separate completely from the body adapter and

Valves were in service for approximately 20 years. The valve type affected is the Modular Integral Double Block and Bleed ball valve, supplied by Dublok to many UK operators in the period 2000-2010. Failures have been observed on a range of valve sizes and pressure ratings, up to 2500#. All failures noted to date have been on uncoated CRA material valves where no additional paint coating was applied over the electroplated body bolting.

Visual inspection of the corroded machine screws as well as “tap-testing” them was carried out on approximately 500 valves, with multiple additional instances of brittle failure exposed. Testing of the failed cap-head bolting showed abnormally high material hardness. The cause of the failure was determined as hydrogen induced cracking (HIC), with the source of the hydrogen being the external corrosion of the bolting.

- Duty Holders with assets where Dublok DBB valves are installed should identify where affected modular valves are installed, and carry out visual inspection and tap-testing of all body bolting to identify if any failures have occurred. Prevention of external corrosion should mitigate the likelihood of HIC affecting the bolting.
- Duty Holders should consider application of strong-back clamps to both valves where bolting failures are uncovered, and also proactively, as there are no reliable NDT techniques to determine the early onset of failure (UT was found effective in lab testing, but surface condition made onsite testing ineffective). Tap testing will only reveal failures where HIC is already highly progressed.
- Prioritization of clamp installation should be by external condition of body bolting and utilisation factor for specific valve size/pressure rating.
