Umbilical support frame made contact with passing vehicle on public road

Safety Flash Published on **22 January 2026** Generated on **28 January 2026** IMCA SF 02/26

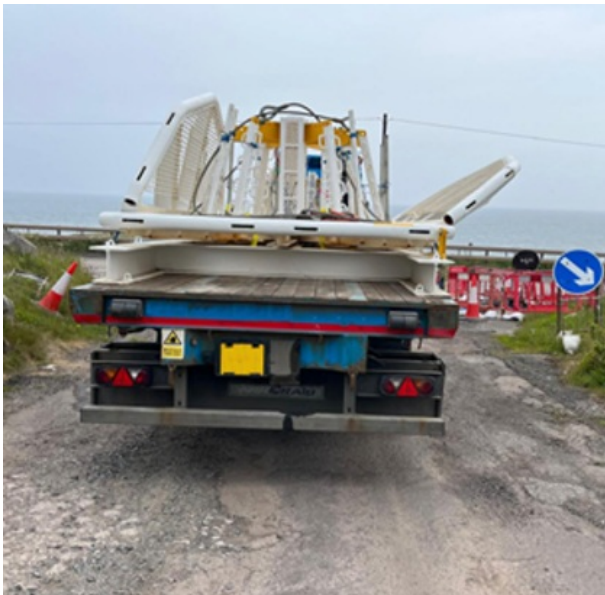
A third party contractor had collected two umbilical support frames (USFs) from a vessel and was transporting them on a public road. Whilst travelling, the right side of one of the frames dropped down and made contact with a passing vehicle.

- The frame was not provided as per drawing/specification – the transportation brackets were missing.
- Upon arrival at the vessel the wings had been stropped together. Although transport brackets had been indicated in the drawings, they were not present when the equipment was delivered.
- There were pins that had to be inserted into the frame, and there was an assumption that these would hold the wings in an upright position for transportation.
- There was no process/procedure to ensure that equipment was going out as per original drawings;
- There was no instruction provided as to how to secure the USF for transportation, neither internally nor to the third party transportation company.
- On departure from the vessel, the load was secured to the trailer but the wings were not stropped.

- Ensure that equipment is provided and received with relevant up to date drawings/specifications.
- Ensure equipment is properly marked with instructions – these frames were subsequently stencilled so it is clear to all parties that the wings need to be secured.
- Ensure that de-mobilisation planning meetings are conducted to confirm tasks and equipment are understood.
 - That self-verifications at project mobilisations/de-mobilisations are conducted;
 - That there is an understanding of the equipment being handled, and,
 - That written instructions are available where appropriate.
- Provide clear instruction to all personnel involved in the movement of equipment – do not assume quayside support workers are familiar with specialist marine or offshore equipment and how it is operated.
