Learning Event

WHAT ARE YOU DOING TO PREVENT TRAILERS DETACHING FROM MOVING VEHICLES?

During heavy vehicle transit, a tri axle tag trailer carrying a padfoot road roller detached from a truck while travelling on a highway.

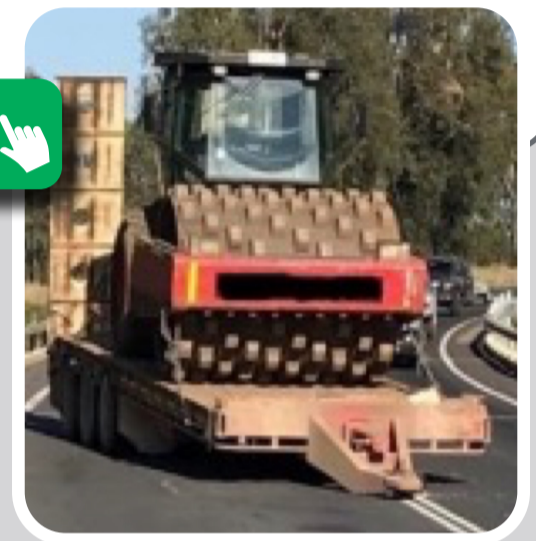
The detached trailer travelled into the opposite traffic lane, striking the guard rail on the opposite side of the road before coming to a stop in the middle of the highway. The trailer travelled 153 metres from the point of detachment.

- The main nut came away from the main pin of the flying saucer hitch component causing the trailer to detach from the truck.
- The trailer load relies on the main nut to maintain its position and once it came away, the trailer frame fell and detached from the truck.
- Significant wear was discovered on the main hitch nut thread, and the main pin had shards of thread still attached (flying saucer style hitch).
- Inspection of the main nut and clamping bolt were not included in regular mechanical maintenance of the trailer.
- The trailer manual does not reference maintenance / inspection requirements for the main nut component of the flying saucer hitch.

- The trailer was hitched correctly to the truck. The components used to connect / disconnect the trailer are completely separate to the main nut and pin.
- Inspections of the truck and trailer are undertaken daily by the operator prior to use. Due to its location, it would not be possible for the operator to properly check the condition of the main nut - this could only be done through a qualified mechanical inspection.
- Verify that an effective trailer hitch inspection and maintenance regime is in place for trailers with this type of hitch.
- Adopt a requirement for two safety chain attachments to be installed on applicable trailers, in accordance with [Vehicle Standard \(Australian Design Rule 62/02\)](#).

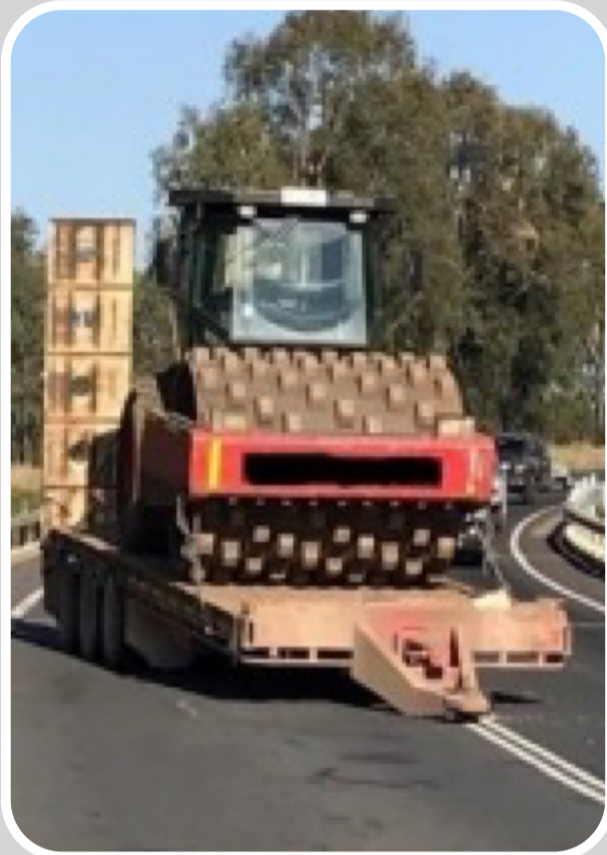
No traffic was travelling in the opposite lane at the time. Load restraints on the trailer were maintained and the roller remained secured on the trailer in an upright position.

Tri axle tag trailer and padfoot road roller post incident.

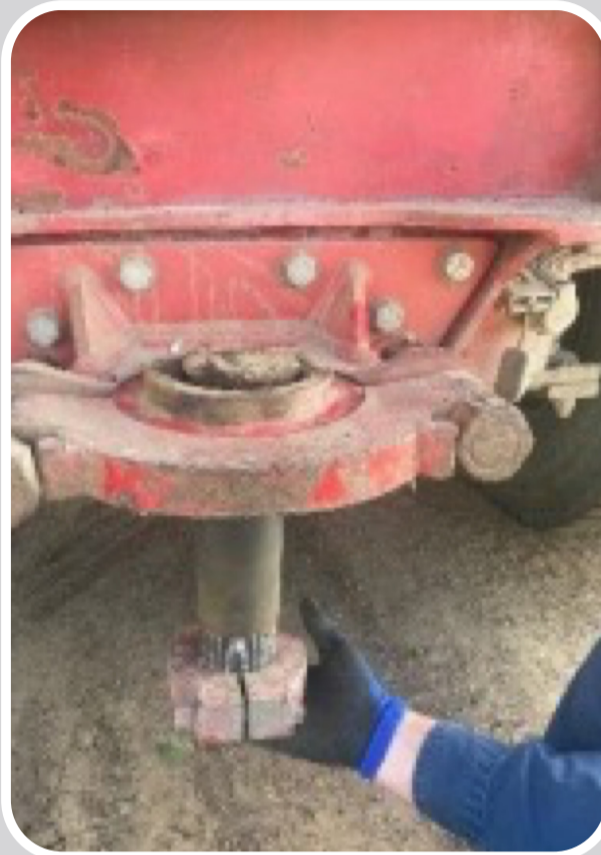
Main nut position on flying saucer hitch assembly.

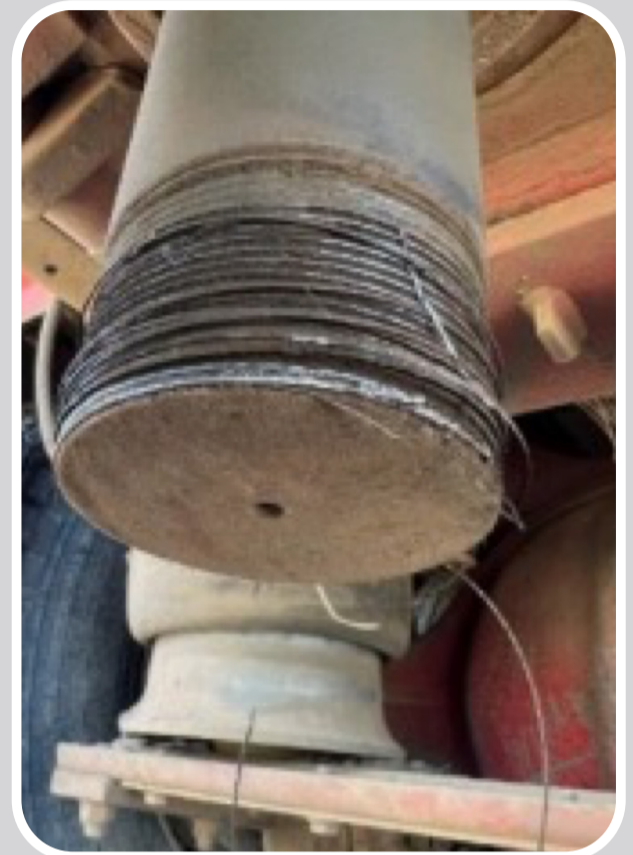
Thread wear on main nut locking pin of flying saucer hitch assembly.
