# Learning Event

## OPERATING A VESSEL

**Person  
in the  
Line of Fire**

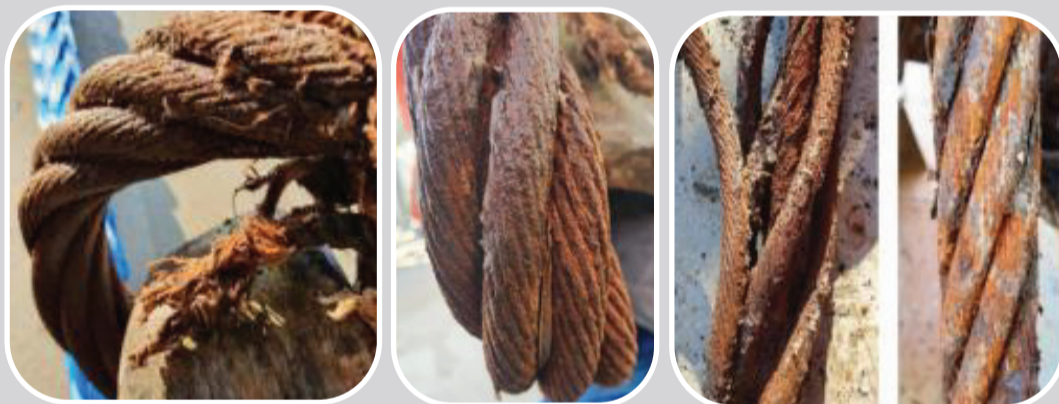
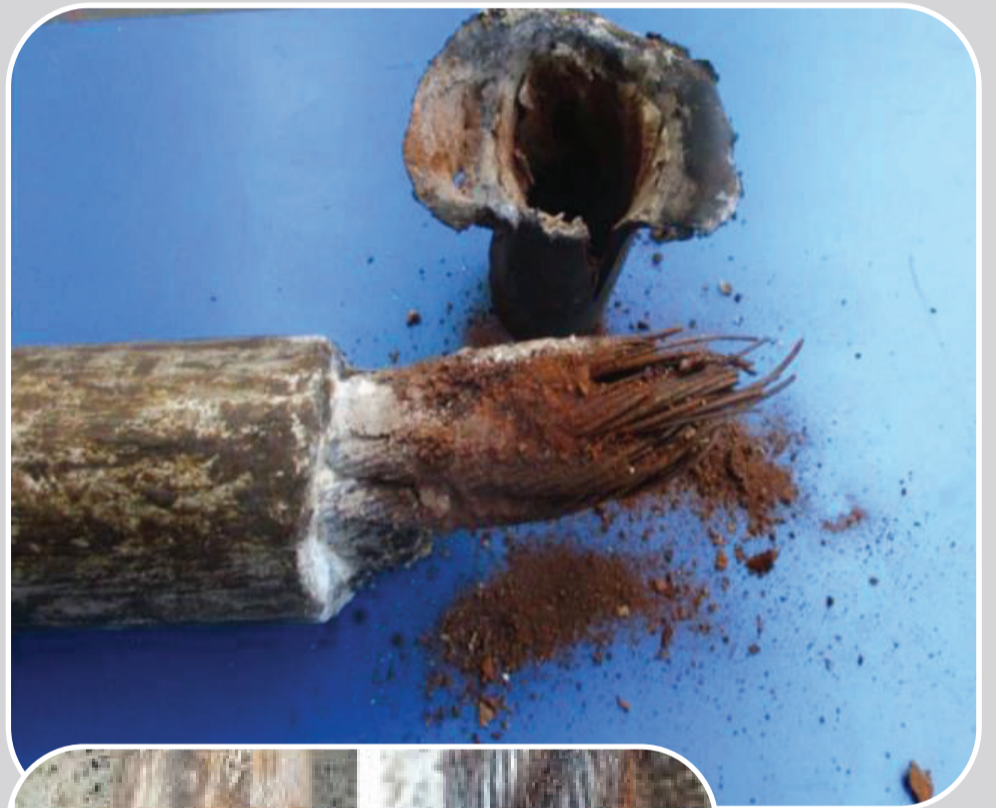
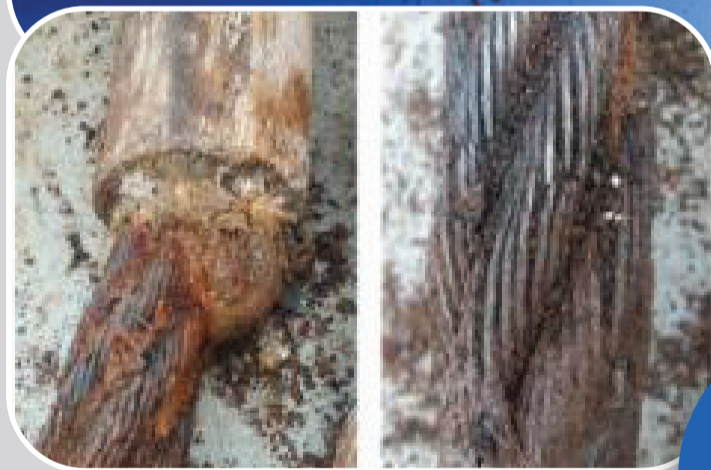
An LPG carrier vessel was alongside a terminal preparing for a scheduled LPG loading activity. After the LPG carrier was secured, one of the aft mooring lines (aft breast line) that connected to the facility mooring hook parted. Infield Support Vessels (tugs) were used to hold the vessel against the facility fenders to prevent movement. The vessel was safely unmoored from the facility. No-one was injured. There was no damage to the LPG carrier or the terminal.

The mooring line parted at a load of 23 tonnes (despite having a certified capacity of 46 tonnes) due to:

- poor condition (corrosion) of wire mooring lines provided by the LPG carrier.
- insufficient assurance of mooring gear.

- Ensure assurance processes are in place for mooring gear.
- Establish Line of Fire exclusion zones when conducting mooring activities.
