Learning Event

WORKING WITH ELECTRICAL EQUIPMENT

**Contact
With Live
Electricity**

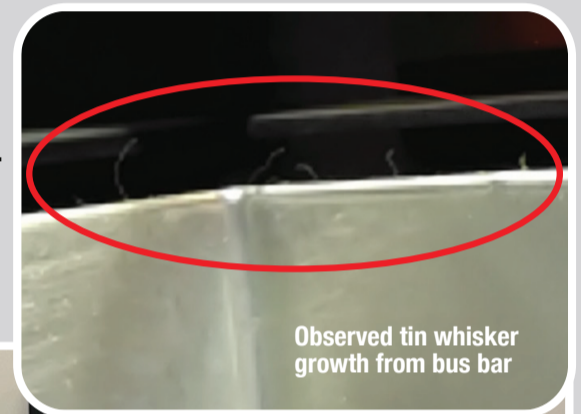
Observed tin whisker growth from bus bar

A phenomenon known as 'Tin Whiskers' contributed to the arc flash. Thin strands or whiskers grow from bus bars over time, effectively reducing the air gap between bus bars, providing an arc pathway.

Tin whiskers are electrically conductive, crystalline structures of tin that sometimes grow from surfaces where tin (especially electroplated tin) is used as a final finish. Tin whiskers have been observed to grow to lengths of several millimetres (mm) and in rare instances to lengths in excess of 10 mm. However, tin whiskers are generally reported to be less than 50 µm long.

- Prior to de-isolation:
 - conduct 1000vDC Meggar testing for insulation resistance
 - clean bus bars to remove any 'Tin Whisker' growth
- Change-out high-risk modules with fully insulated bus bars.
- Update design specification to increase minimum air gap to account for 'Tin Whisker' risk.

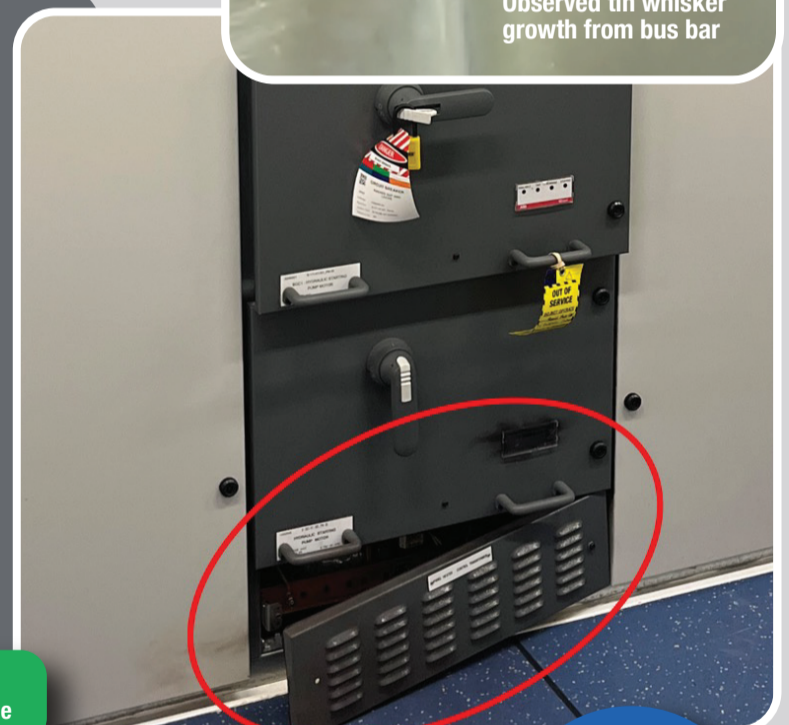
Module bus bar clearances were found to meet the minimum standard (>8mm). However, the standard does not account for the possibility of 'Tin Whiskers'.
