Description of incident:

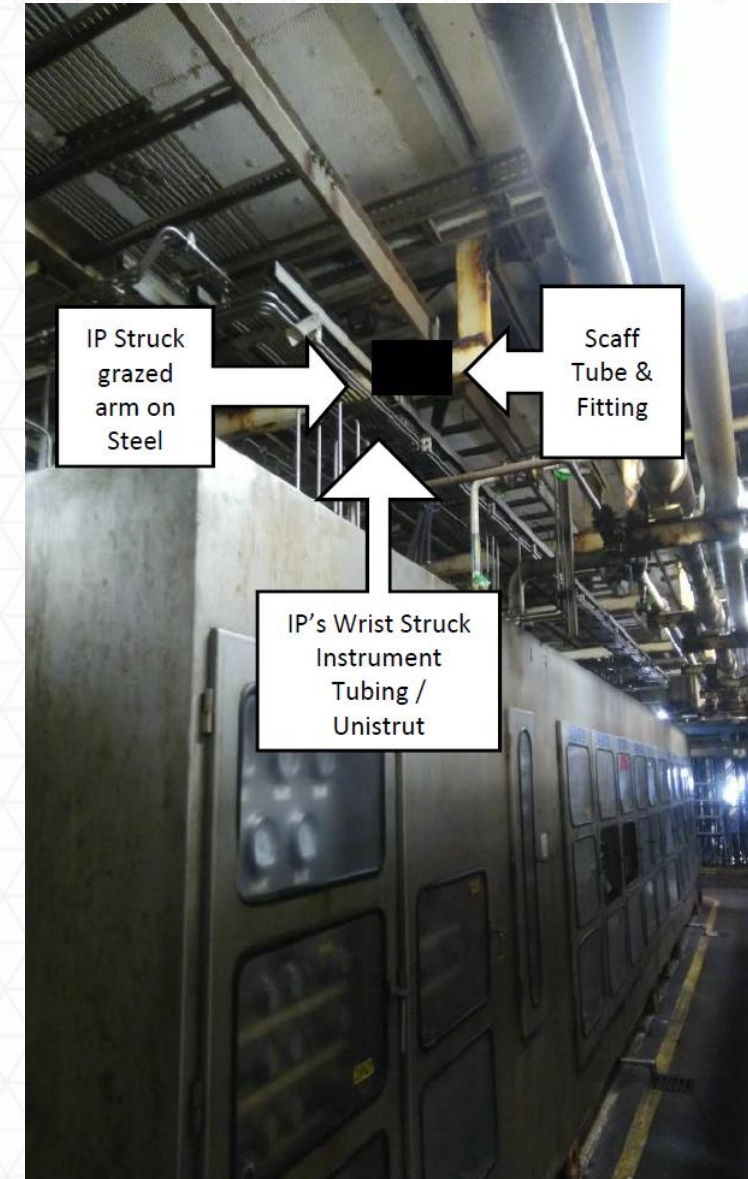
The Injured Party (IP) was dismantling a handrail with a long reach heavy-duty ratchet spanner.

The spanner slipped, which resulted in the IP grazing their arm on the steel beam and impacting their wrist on the instrument tubing and unistrut.

- The root cause was determined to be inadequate spatial awareness, and the chosen tool, in this case a long reach heavy-duty ratchet spanner, slipping off the fitting.

- The work area was tight and restrictive, creating high potential for line of fire hazards. Restricted workspace, low headroom, and potentially tight or seized fittings were noted on the Toolbox Talk form as hazards.

- It is recommended that scaffolding structures are always dismantled as soon as practicable. Clients / Duty Holders should consider the impact weather (particularly offshore) can have on degrading the integrity of scaffolding materials, and the increased risks of personal injuries when undertaking deconstruct.
- All personnel to be reminded of the need for prompt reporting of incidents and the need to seek immediate medical attention where any injuries are sustained.
- Highlight the importance of staying focused throughout the entire task.
- Ensure all risks captured as part of toolbox talks and risk assessments are addressed and managed through the appropriate control measures.
- Ensure careful consideration is given to tool selection based on risk, and that the correct tools are available for the job.
