## Description of incident:

The scaffolding team on a North Sea installation observed a loose scaffold board on a habitat roof. An intervention was made before any harm could be caused because of the work environment conditions, e.g. adverse weather.

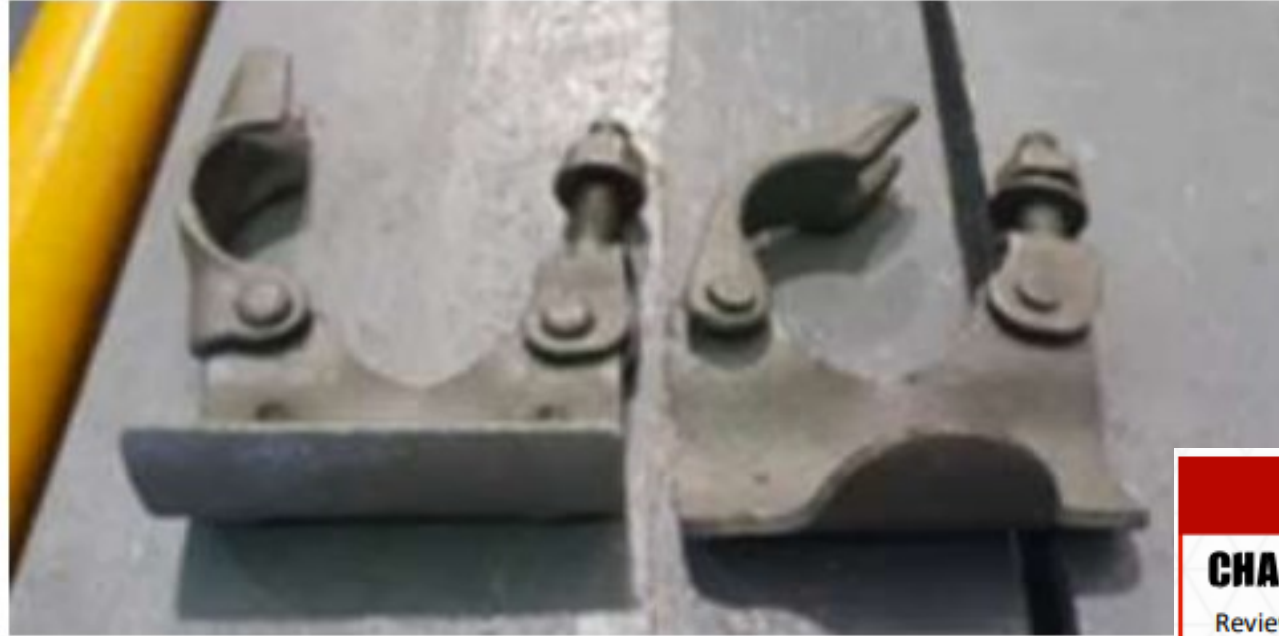
The Scaffolding Focal Point observed the incorrect single coupler for securing scaffold boards had been utilised hence the reason the board was loose.

Scaffolding personnel must ensure they are in possession of and use the correct equipment/tools for the job at all times. Whilst both couplers below are fit for purpose, only the coupler on the right of Figure 1 with the curved lip should be used for securing scaffold boards.
