# Safety Alert

**Number: 25-15**

**Subject: Fall into Chain Locker**

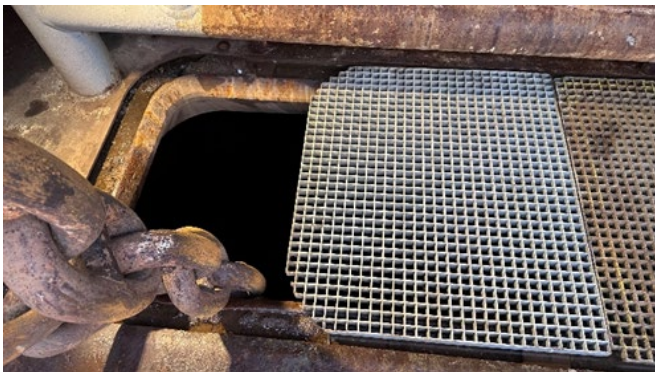
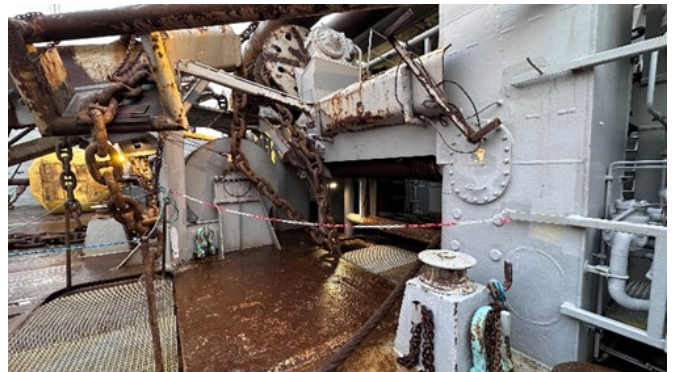
## Photographs / Supporting Information

Whilst working onboard an anchor handling vessel alongside in port, an Able Seaman (AB) fell into an open chain locker (~8 meters deep) during mobilisation for pre-lay workscope.

- Open hatch left unsecured after previous operations.
- Poor lighting in the chain locker area (light above locker was off).
- Issues with communications.

- Implement robust communications with the bridge when operating hatches.
- Ensure all openings are secured immediately after use/operation.
- Improve lighting in operational areas and verify before work starts.
- Reinforce STOP WORK authority for unsafe conditions.
