## Saturation diver exposed to chemicals from pipeline

Safety Flash Published on 6 February 2025 Generated on 3 March 2025 IMCA SF 02/25

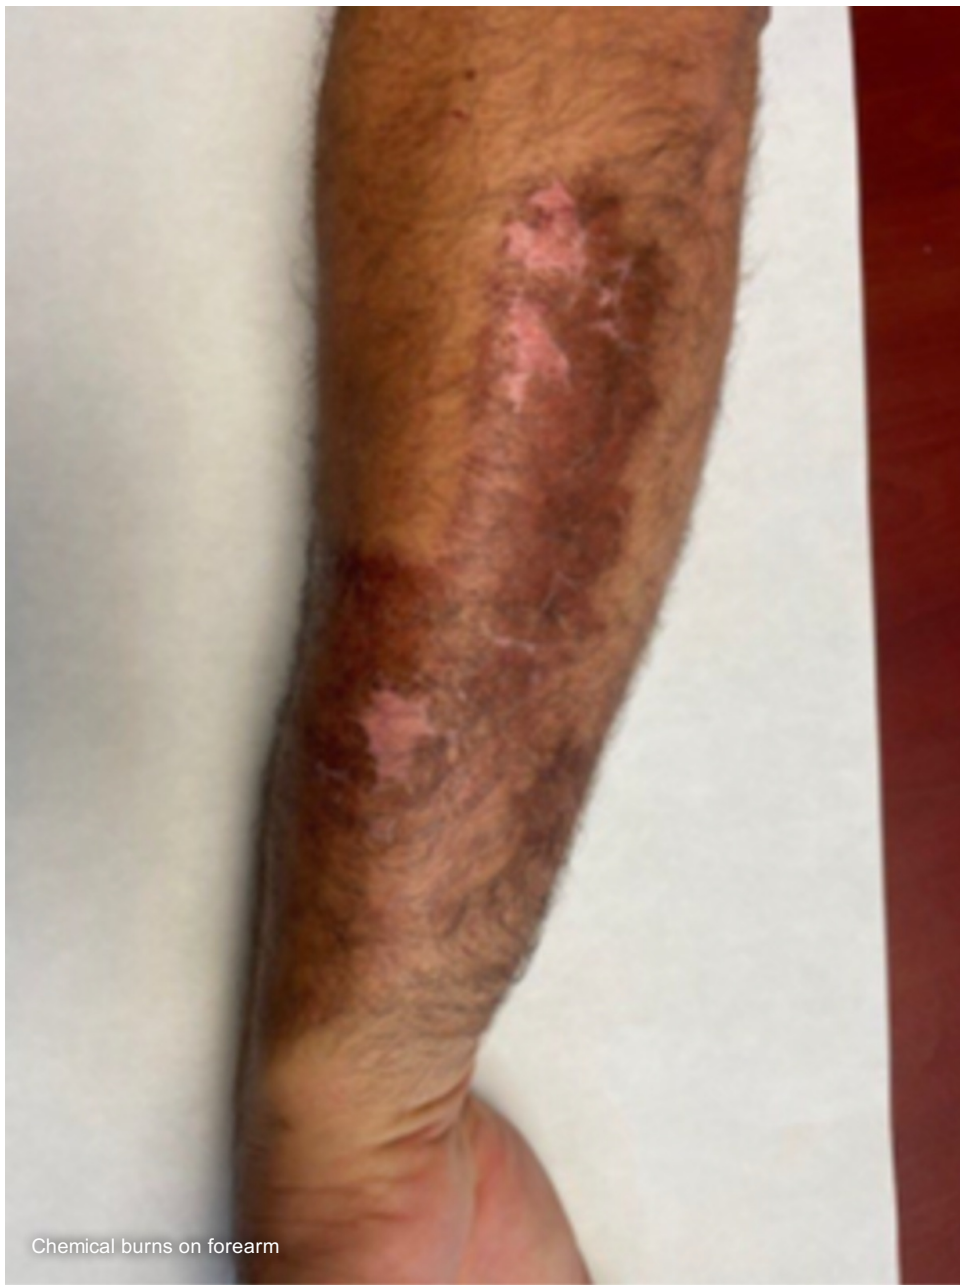
Subsequently the diver noted light scabs forming on the left forearm and light blisters on the right, and burn cream was applied. The divers went onto decompression shortly afterwards as the job was over. The company Diving Medical Officer diagnosed first degree chemical burns to the neck and second degree chemical burns to both forearms. The diver was in due course cleared to return to assigned duties.

Chemical burns on forearm

- Identify all risks and include them in the Hazard Identification and Risk Analysis. In this case “it was thought” that the lines being handled had been flushed.
- Ensure there is a full understanding of pipeline contents before flushing operations.
- Amended procedures for operation to include:
  - warnings conveying possible contact with hazardous pipeline contents.
  - steps to isolate valves regardless of pipeline contents.
- Use of barrier cream by workers during hose or pipeline disconnect operations for any pipeline operation.
- Upstream and downstream valves on flushing assemblies should be secured before disconnecting flushing equipment.
- Plan to minimize diver exposure to pipe or hose contents by addition of local valves.

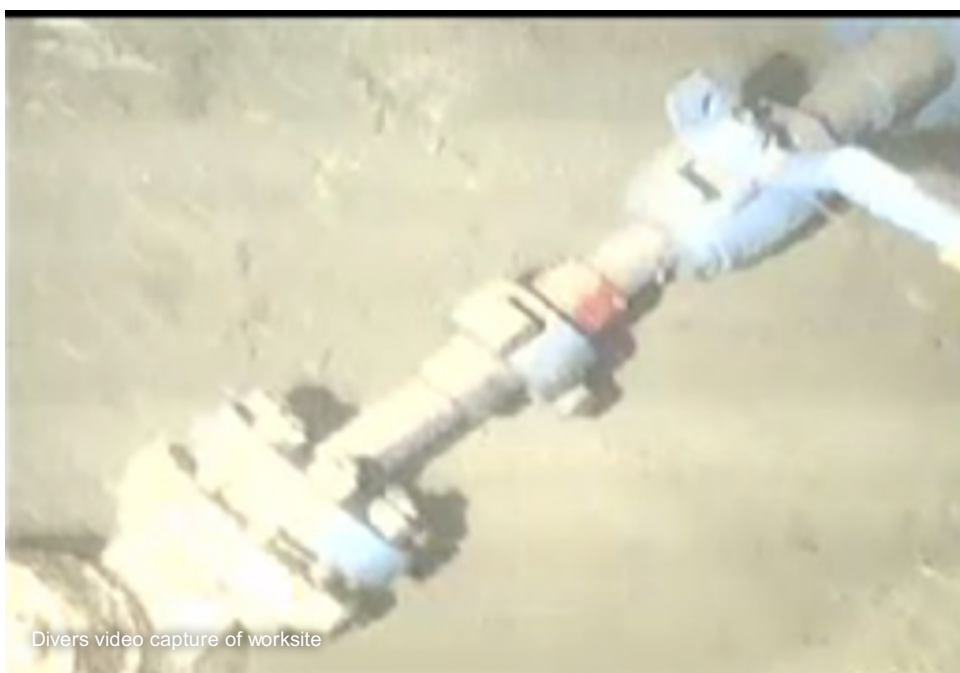
The incident occurred during a bell run to disconnect a 5cm pigging/flushing hose. During the disconnect process, the diver became exposed to the contents of the pipeline. The diver noted discomfort to exposed areas of the wrists and arms and was recalled to the bell. At the bell, the affected areas were cleaned with a mild soap. The divers' suit and gear were removed and stored on the outside of the bell. The bell run was terminated, and the divers returned to the chamber complex for evaluation and monitoring. In the chamber the diver thoroughly washed with soap and cool water, and applied burn cream to the affected areas.

Divers video capture of worksite

- There was a lack of communication as to whether or not the line being handled by the divers had been flushed
- There were no engineered barriers in place to prevent the divers from coming into contact with hazardous substances from the pipes.
