Hand tool Lithium battery fire in moonpool

SAFETY ALERT

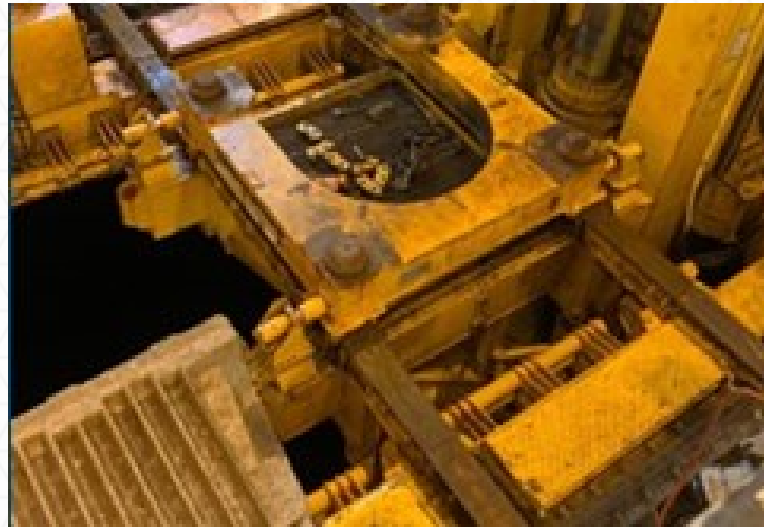
The BOP transporter platform was inspected, and the burned remains of the power tool lithium battery was identified as the source for the flame. The battery was not connected to any tool.

Cause - The lithium battery was exposed to a liquid/wet environment and caused a meltdown/burst into flame

Consequence – Damaged battery

- Always carry out pre-use checks of tools/equipment
- Use and store tools/equipment in accordance with the user manual
