Description of incident:

Cutting of gratings to create end strips using a 9-inch hand grinder.

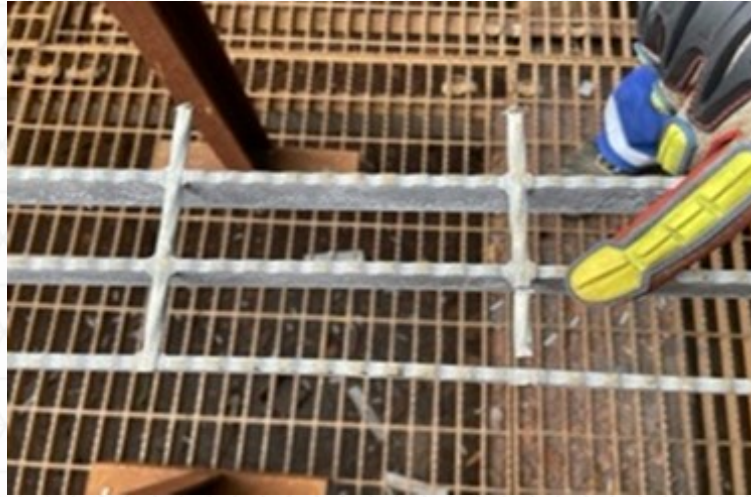
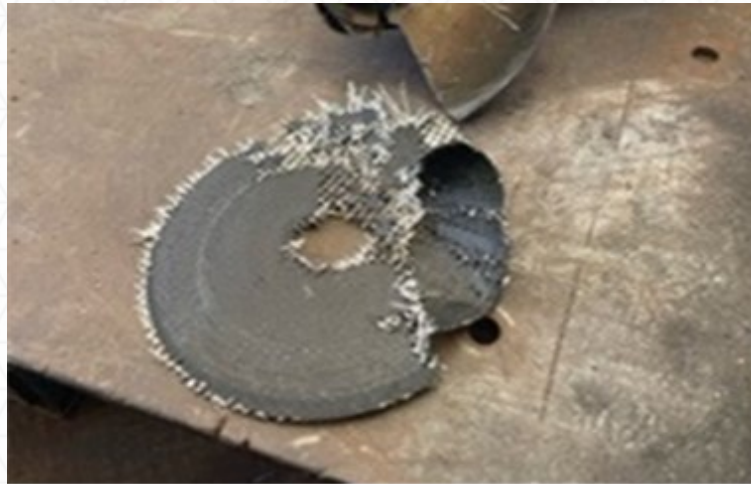
- The grinder cutting disc disintegrated during use
- This caused the grinder to kick and twist in the IPs hands, and for the remnants of the rotating disc to come in to contact with the palm of the IPs left hand
- This caused a 5cm laceration to the pad of the hand just below the operators little finger
- The IP (Injured Party) was seen by the platform medic and the following day flown to the beach to receive hospital treatment where the wound was cleaned and stitched

The size of grinder used during the task (9 Inch) was larger than required resulting in increased kick back and awkward position during operation.

Incorrect PPE was worn during the task. The gloves worn were not on the company PPE Matrix and did not provide adequate cut protection from grinding.

The disc may have been faulty due to centre boss instability. (This is to be confirmed once manufacturer has complete associated testing)

- Do not use a grinder that is larger, heavier or more powerful than is necessary, as it is much easier to control a lighter tool. The increased power and size of the 9-inch grinder will cause more severe kickback.

- Ensure that the correct type or size of disc is used for the task being performed. The wrong disc could shatter or 'grab' the material causing kickback.

- When using a grinder fitted with a cutting disc, keep the depth of cut to no more than double the disc thickness and avoid plunging the disc too far through the material. This could 'grab' the disc and cause kickback.

- A risk assessment to identify alternative methods and tools should be carried out prior to selecting a 9-inch (230 mm) angle grinder. For example, a Cengar saw or smaller grinder.

- Correct PPE to worn when using Grinder with adequate cut protection and wrist protection. (Cut Level 5 Gloves with Wrist Protection).
