## Broken equipment repaired or replaced

Safety Flash Published on 17 November 2025 Generated on 1 December 2025 IMCA SF 21/25

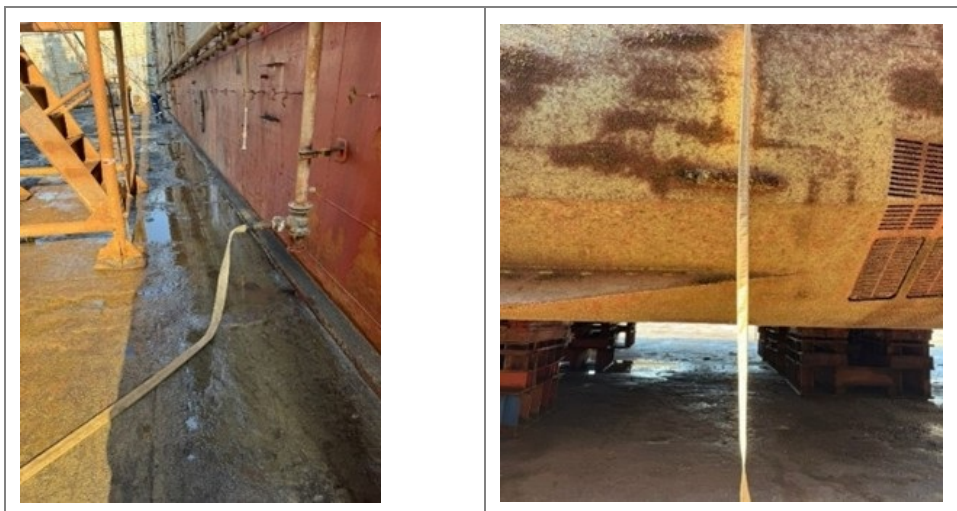
#### 1) Fire fighting pump:

On a vessel being dry-docked for cleaning of the box cooler system, it was noted that the firefighting pump for the dock was not operational and line not pressurized. The issue was taken to the management of the dry-dock and the fire fighting system was energised and made operational.

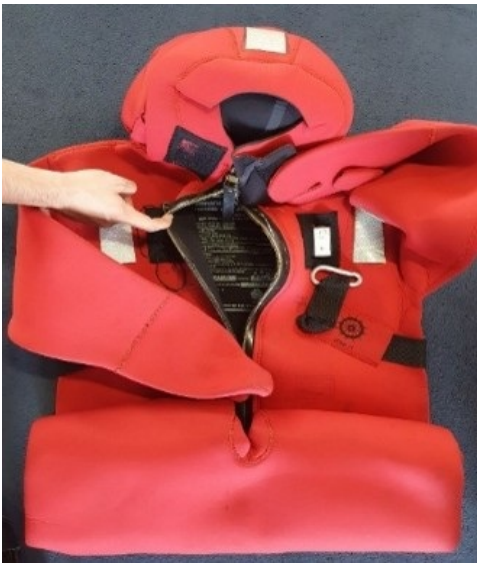
#### 2) Immersion suit:

During a monthly inspection, it was observed that the zipper in an immersion suit zipper was sticking and not functioning properly. The company was promptly informed, and a new certified immersion suit was delivered on board without delay.

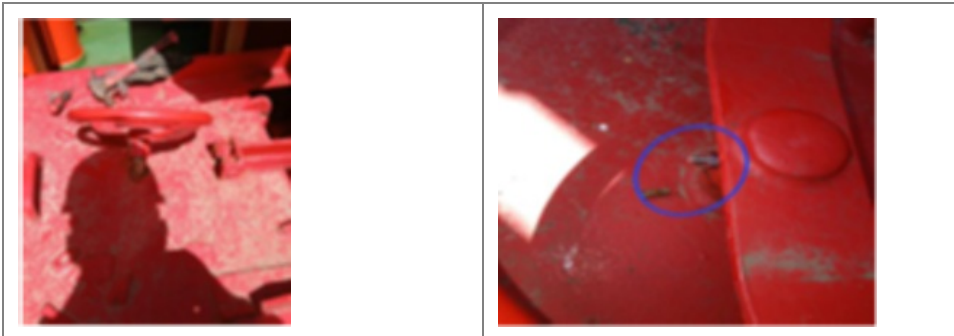
### 3) Broken emergency exit handle:

It was observed that the handle of one of the emergency exits located on the main deck was broken. A broken handle on an emergency exit door can delay evacuation during emergencies and put crew members at risk. It may cause panic or overcrowding at alternative exits, further slowing down escape. The handle was repaired immediately.

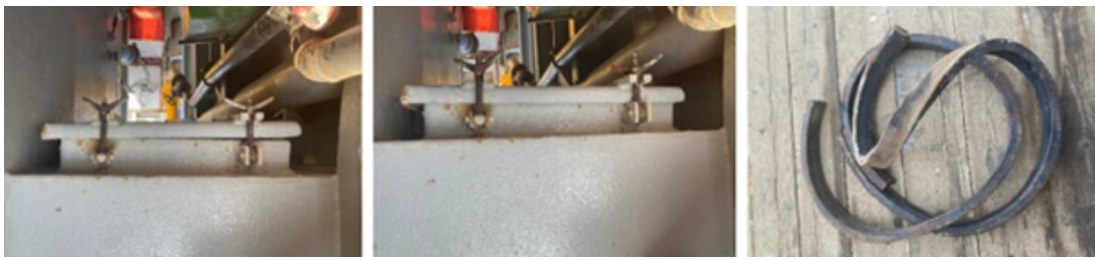
### 4) “Perished” rubber on Ventilation Flap:

During a scheduled fire drill, the crew attempted to close all the ventilation flaps located on the main deck. These flaps are critical to fire safety, as they are designed to restrict the flow of oxygen and assist in extinguishing fire. It was observed that one ventilation flap would not close fully. This was because of deterioration of the rubber seals, which had dried out and worn, preventing a proper airtight seal. This condition was not identified earlier during routine inspections.

- Incomplete closure of ventilation flaps could allow continuous airflow to a compartment during a fire, potentially fuelling the fire and reducing the effectiveness of fire-fighting measures.

- Action was taken to replace the defective rubber seals on the affected ventilation flap, and inspect all other ventilation flaps and seals on board to identify any similar deficiencies. A condition check of rubber seals was added to the planned maintenance system, and care was taken to ensure spares were held on board.

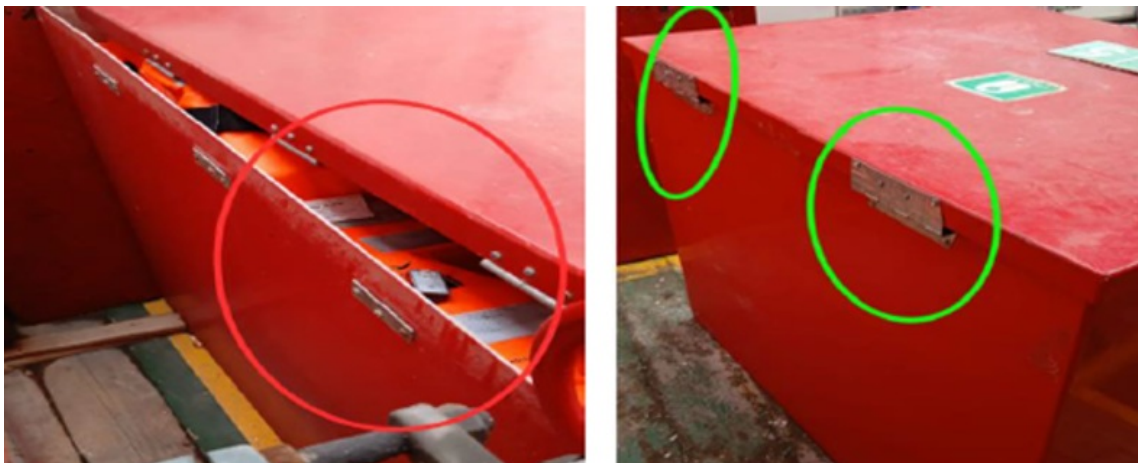
## 5) Damaged Hinges on Lifejacket Storage Box:

It was observed that the hinges of the box storing lifejackets were broken. In an emergency, crew members should be able to open the LSA (Life-saving Appliances) box quickly to access lifejackets. Broken hinges could prevent the lid from opening, causing critical delays and posing serious risks to crew safety. Additionally, unsecured lids may allow seawater ingress or accidental loss of equipment.

- The issue was immediately reported to the Chief Officer, who immediately arranged for repairs. Arrangements were made for regular inspection and maintenance of such boxes, with particular attention to hinges and securing arrangements.
