Dropped pallet during cargo transfer

Safety Flash Published on 4 December 2025 Generated on 4 December 2025 IMCA SF 22/25

A plastic pallet loaded with plastic lube oil drums fell while being hoisted.

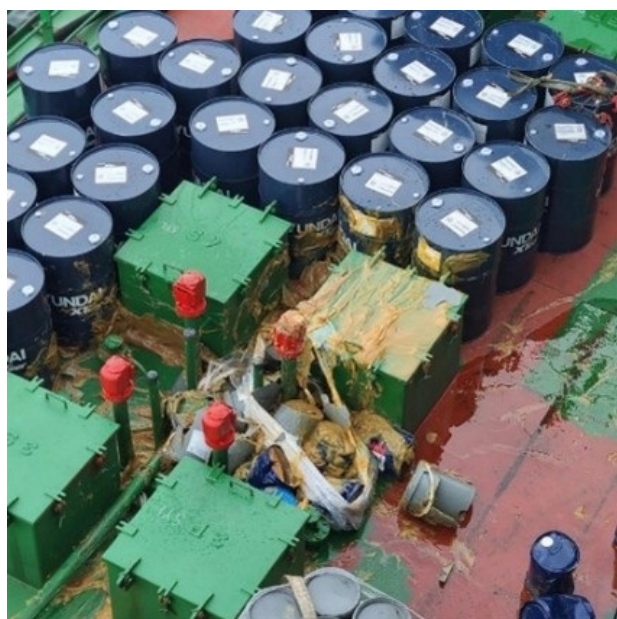
During transfer of lube oil drums via barge to a vessel in an anchorage, a plastic pallet loaded with plastic lube oil drums fell while being hoisted. The incident resulted in product damage (ruptured drums, oil spillage on deck). There were no injuries nor structural damage.

- The pallet was inadequately secured before lifting, and when it was lifted, it was an out of balance load and tipped over.
- There could have been more adequate secondary securing of the load – straps or netting.
- There could have been more and better supervision of the barge crew during cargo lifting operations.
- There was perceived “time pressure” at work.
- There was unchallenged reliance on routine – “we’ve always done it this way”.

- There were procedures in place for this lifting operation but they were not followed;
- There was a lack of clear communication and coordination between ship crew

- and barge crew;
- Insufficient training/awareness of safe lifting practices with plastic pallets.

- Ensured thorough pre-checks of all cargo loads, however small, before lifting.
- Ensured cargo loads are adequately strapped and secured and “in balance” before lifting.
- Reiterated need for toolbox meetings between ship and barge crew before work starts.
- Ensured better oversight and supervision of cargo lifting by ship’s duty officer.
