MSF: High potential near miss during FRC maintenance

Safety Flash Published on 24 March 2026 Generated on 31 March 2026 IMCA SF 06:26

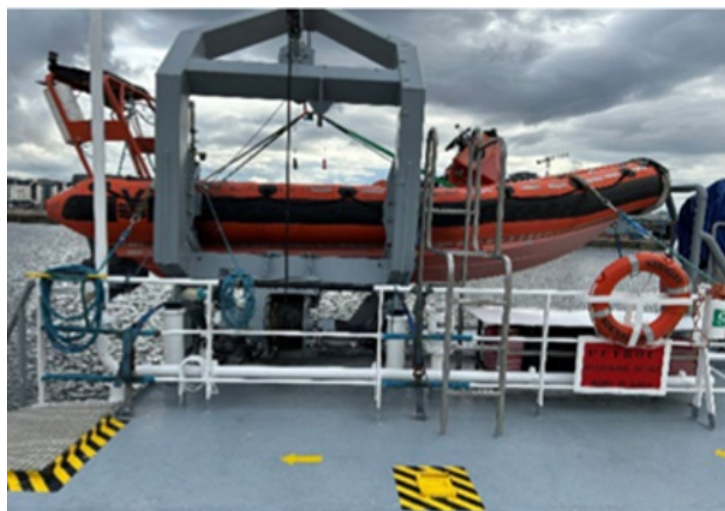
On a vessel, work was being conducted on a change-out of lifting slings on one of the Fast Rescue craft (FRC). This was considered a routine task that had been conducted many times at sea before, and it all appeared to be going well. During the change out of the lifting slings the FRC slipped from the davit cradle whilst two crew members were actually onboard the boat. The FRC went into an uncontrolled descent to sea with both crew members having to jump into the water clear of the falling boat. Both persons were recovered unharmed.

- It was found that the FRC was only secured by the aft bousing line;
- As the FRC came clear of the davit and started to fall, the stainless steel carabiner on the aft bousing line failed.
- The task could have been planned and executed much better:
 - Whilst it was considered a routine task, there was no written or formal procedure, and no risk assessment.
 - Whilst a Toolbox talk was undertaken, this did not fully cover all the aspects of the work to be undertaken;.
 - There ought have been a Permit to Work.
 - The work was originally planned for the afternoon watch, however at short notice it was decided to attempt to try and complete the task in the morning.

- This was a complex and multi-faceted operation, with many different aspects; it ought not have been considered a “routine task”.
- Review all tasks that you consider to be routine, take the time to review and observe, don't ever accept 'we have always done it this way' There might just be a safer alternative.
- Question complacency: “This is the way that we have always done it”? It's OK to feel uneasy and uncomfortable about a task, and if necessary, STOP THE JOB.
- Did the task have to be conducted at sea? Could it have been done later when alongside?

In this case, one of the vessel owner's actions was - don't change FRC slings or davit wires while at sea.
