Worker suffered crush injury while handling unstable steel plates

Safety Flash Published on 14 May 2026 Generated on 14 May 2026 IMCA SF 09/26

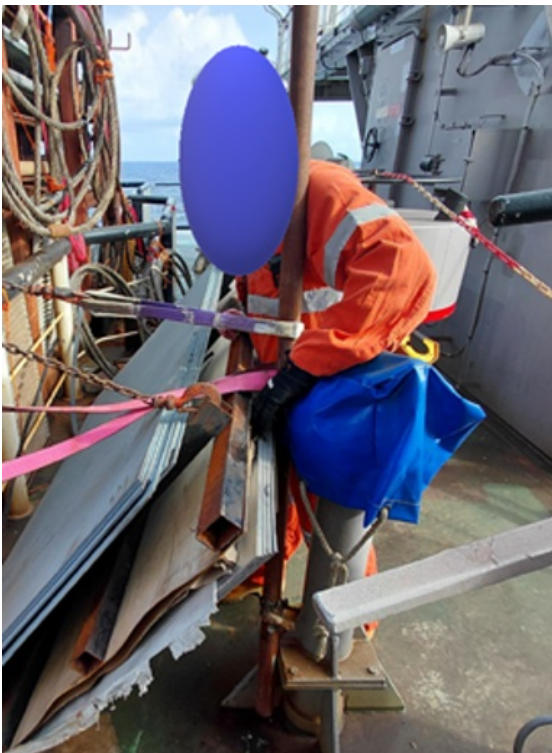
Steel plates suddenly toppled over to the side trapping a worker's left hand and wrist between a frame and an emergency stop pedestal.

A worker was using their left hand to hold a number of steel plates in a vertical (balanced) position. One of the plates suddenly toppled over to the side trapping their left hand and wrist between a frame and an emergency stop pedestal. The worker suffered crush injuries resulting in multiple fractures to the hand, wrist and fingers requiring surgery. Also, the falling plate caught the worker on the left side, causing a superficial laceration to the abdomen.

- The steel plates were being stored in a temporary arrangement outside the designated steel rack:
 - There had been no supervisory oversight of the decision to store the plates in this temporary way;

- There was limited space in which to work.
- Sea fastenings had been removed during voyage, increasing risk of plate movement.
- Work as planned, work as done: the risk assessment did not reflect real task conditions.
- The task had been done this way without any problems in the past. Perception of risk could have been better:
 - The workers just got right on with the task and did not pause for a last minute risk assessment;
 - No manual handling aids were used.

- Do our risk assessments always reflect the real world of work – i.e. work as DONE?
- Do risk assessments take into account “temporary” changes that sometimes become effectively permanent?
- Can we design and arrange storage to prevent this kind of thing happening? Have a look at the way materials are stored, particularly when “temporary” storage may be involved.
- Stop and think – take time out to think things through!
