Injury after fall from vertical ladder

Safety Flash Published on 27 October 2025 Generated on 29 October 2025 IMCA SF 19/25

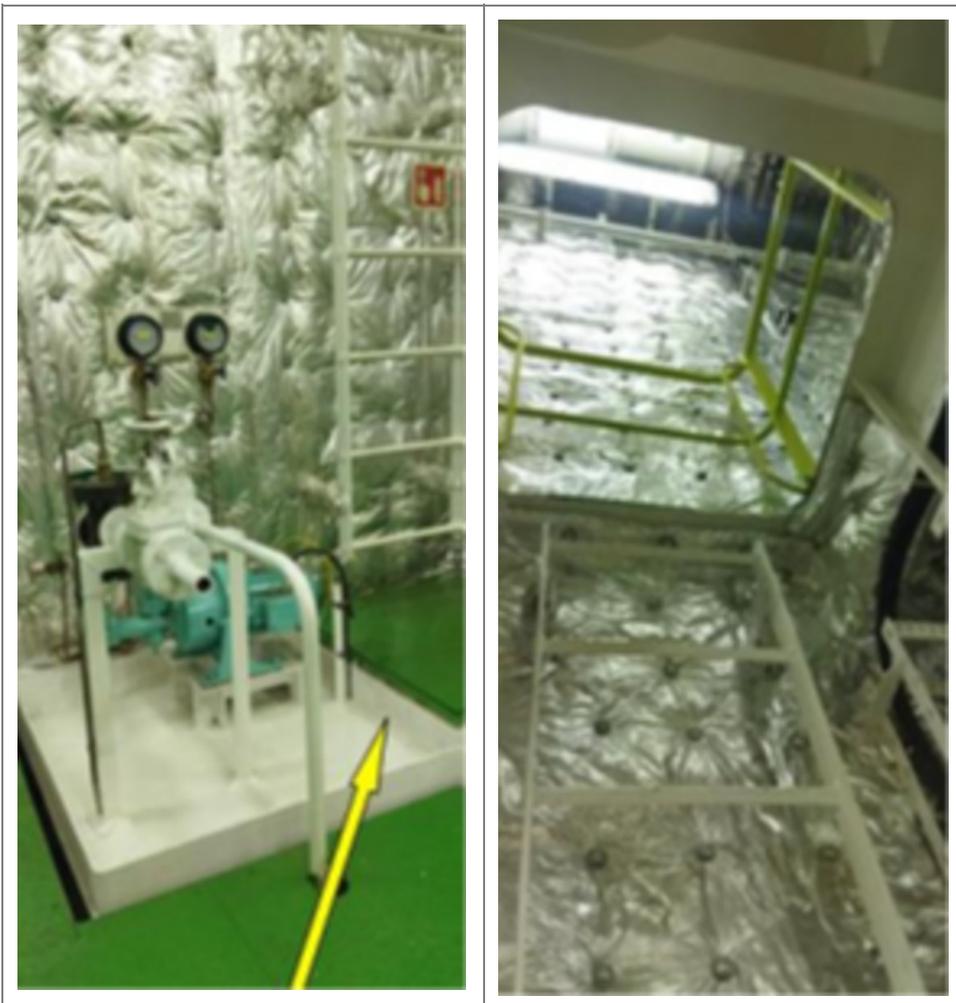
The incident happened when they were climbing up the 3m high ladder; one of them was holding a fire patrol device in one hand. That crew member lost grip on the handrail at the top of the ladder, fell and hit their head on the edge of a steel bund on the deck, sustaining a minor cut to the right eyebrow. #

- The crew member was climbing the ladder whilst trying to carry something in their hand.

- The ladder did not extend far enough to the next level up to provide safe access.
- There was no anti-slip grit applied on the rungs of ladder.

- The design of the vertical ladder and its location/position made it easy for the crew member to be unsafe
 - It was an inadequate and unsuitable design.
 - A ladder extension could have been provided.
 - Anti-slip paint could have been used on the rungs.
- Some form of bag or carrying device could have been provided for the “fire patrolling device”.
- The task was seen “routine” and there was an unchallenged acceptance of the method of carrying it out
 - Trying to climb a ladder whilst carrying something in their hand.
There was little awareness of the potential risks involved in this task.
- Opportunities to stop and consider the risks of the job – discussing a JSA, holding a toolbox talk before starting work – could have been taken.
