SAFETY ALERT

Lid from decommissioned open vent line fell onto walkway during heavy winds

Location: *OFFSHORE : Floating Production Storage Unit*

Safety Alert number: 352

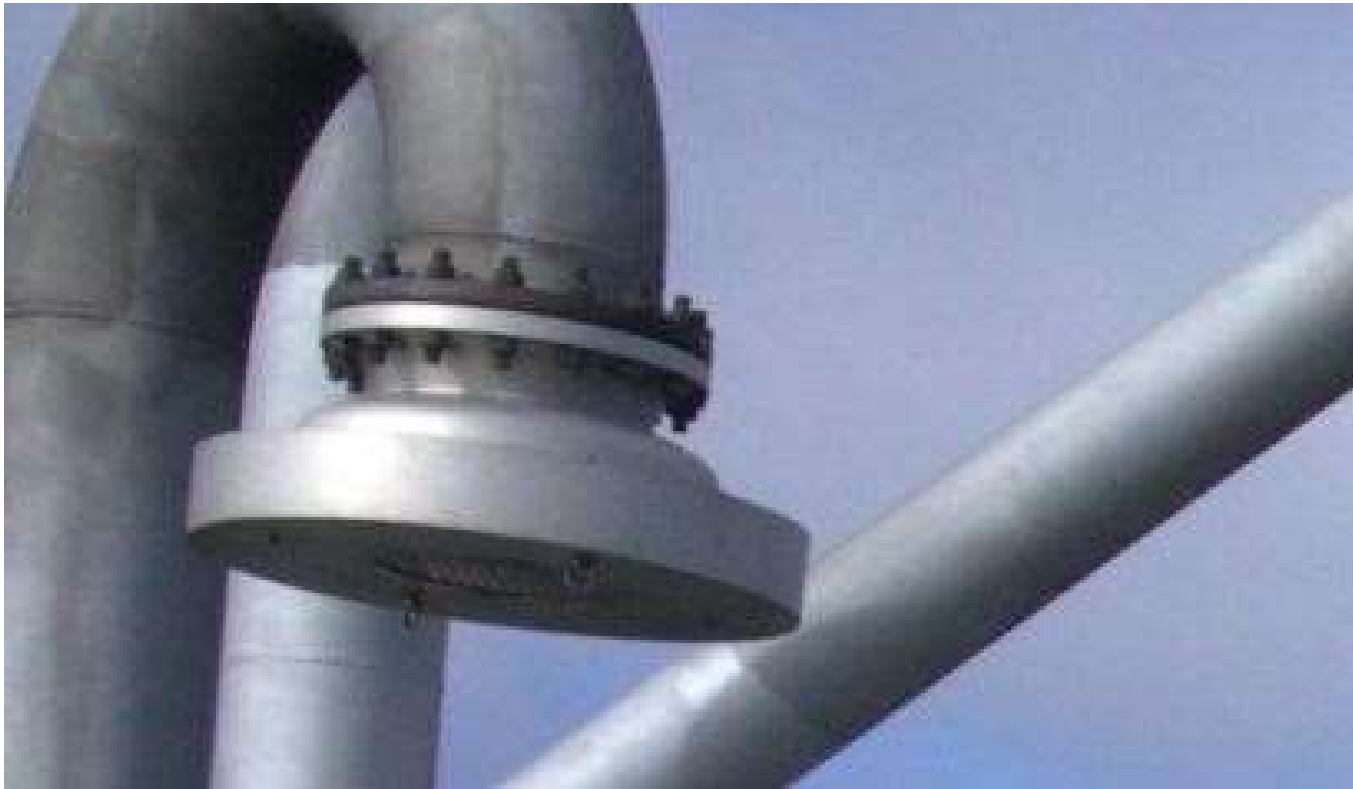
A "bird screen" lid with a weight of 20 kg which had been bolted on to a decommissioned atmospheric vent line fell down on a walkway 37 m below during a period of high winds (50-60 knots).

- The vent line lid was designed to be installed on a vent facing upwards.
- The lid, as installed, did not have any means of secondary retainment since the lid had not been identified as a potential dropped object.

Figure 1: Lid while installed on the atmospheric vent line

- Review of decommissioning procedures to cover the risk of potential dropped objects.
- Review and improve inspection routines for potential dropped objects, physical and drone based.
- Review requirements for establishing tag numbers for other decommissioned equipment that could deteriorate into hazardous conditions.

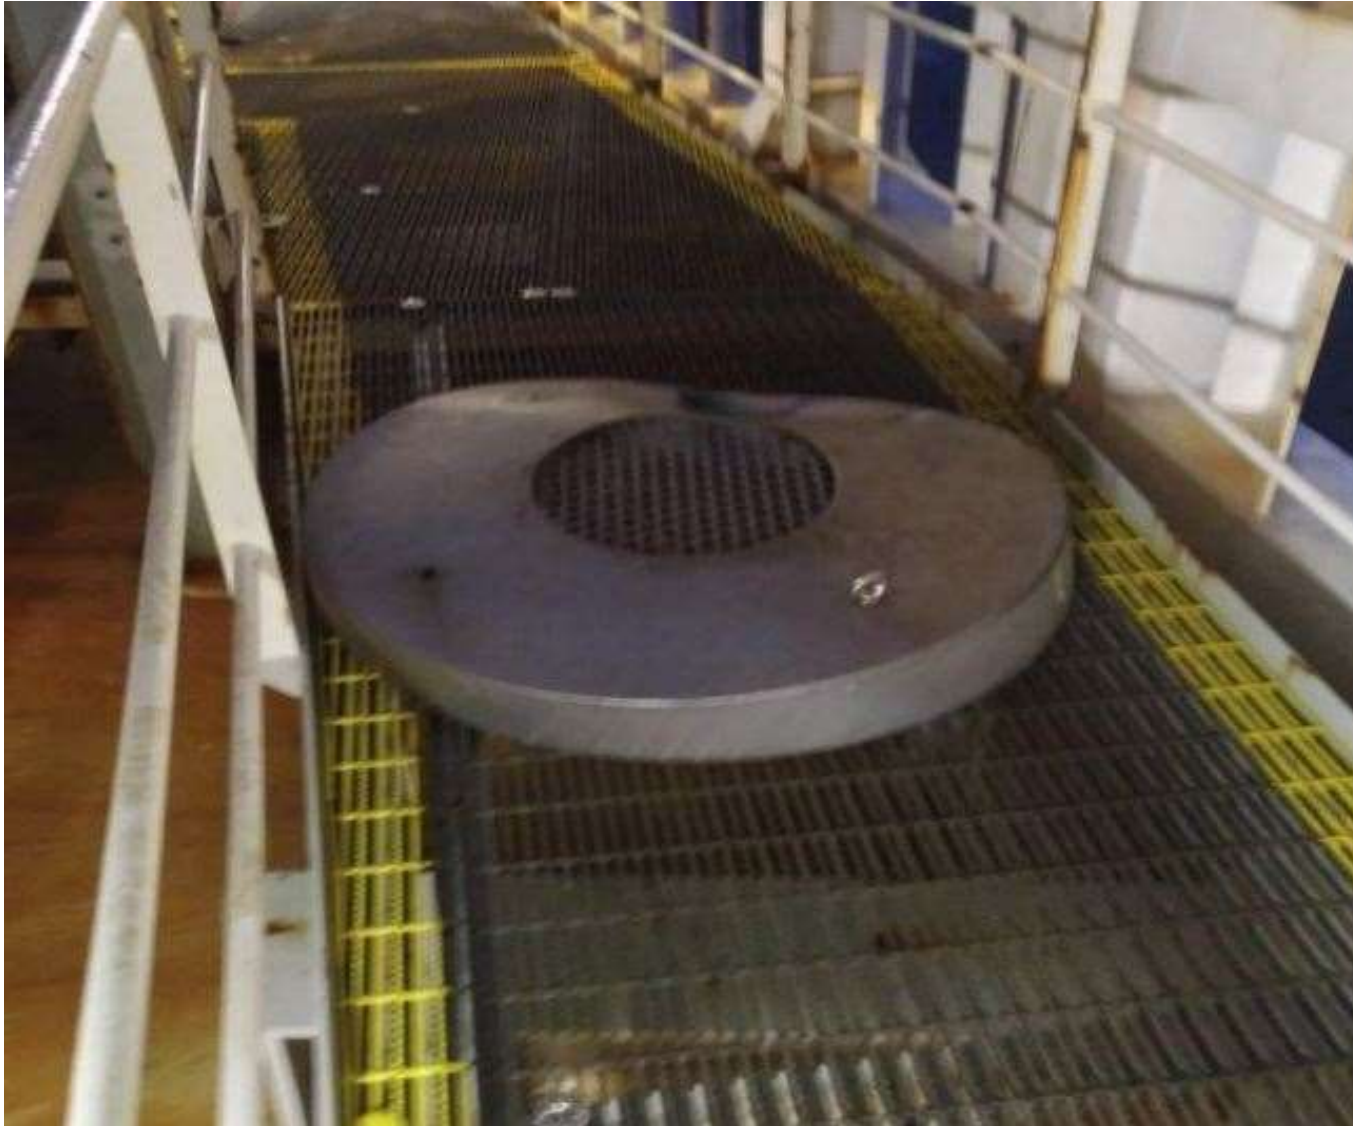
Figure 2: Lid after it had fallen down on walkway

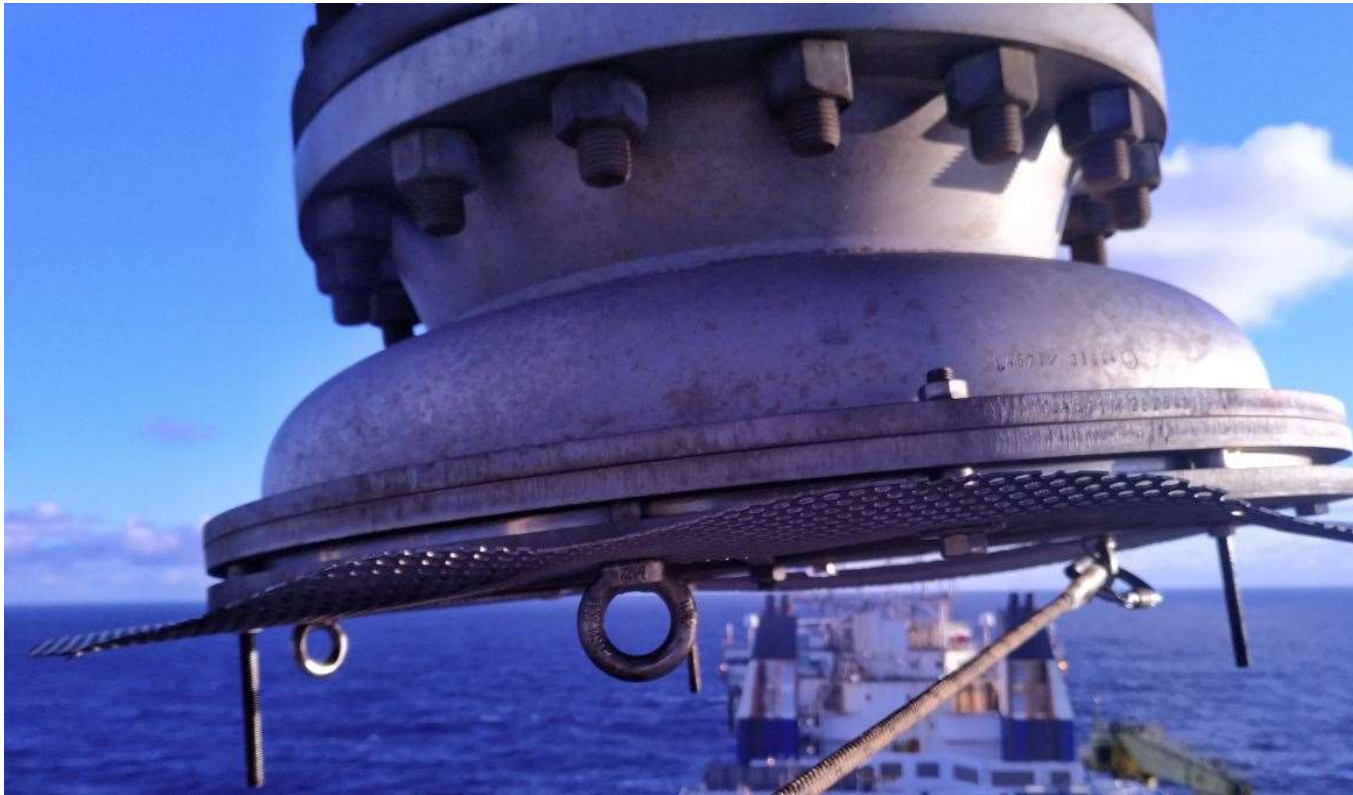
- The original tag number of the vent line was set to "deleted" after being decommissioned, hence leaving it without a formal trace in the maintenance program.

Figure 3: Atmospheric vent line after the lid had fallen down
