Safety Alert

Number: 25-16

Subject: Unknowingly in the Line of Fire

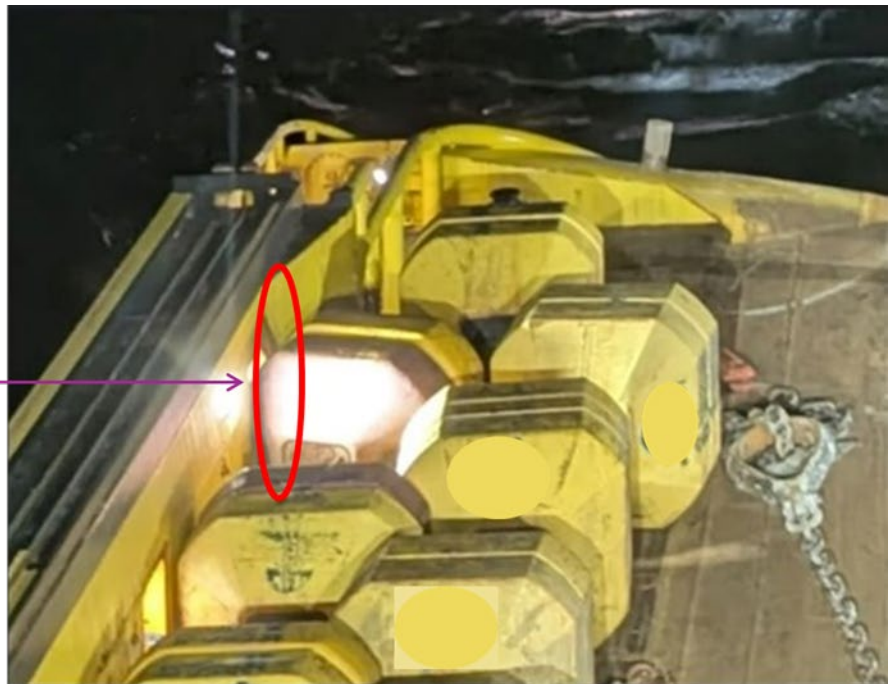
IP location

Post heavy weather, and during Anchor Handling Vessel (AHV) mooring operation of a Semi-Submersible Drilling Unit, an Able Seaman (AB) was caught between subsurface buoyancy unit and safe haven after release of sea fastening lashing wire. AB sustained crush injuries to chest area and was medevac'd to hospital.

AB and deck crew, during operations, did not recognise that they were in the line of fire from stored energy contained within lashing system.

Review deck handling risk assessments with particular reference to situational awareness when deviating from planned procedures, recognising change.

Focus on Stored energy when releasing of lashings.
