### Description of incident:

Electro-magnetic on magdrill accidentally turned off, which released the tool from its position and entrapped the operator's hand between the tool and bottom joining plate.

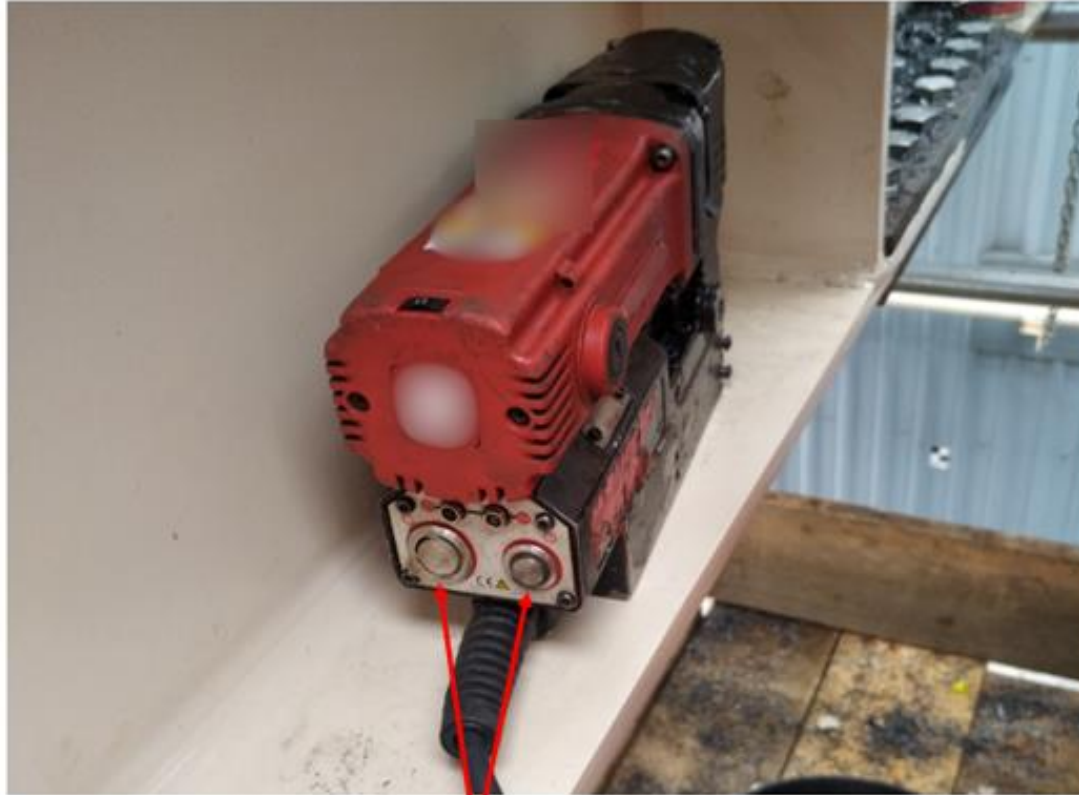
Poor ergonomic design of button controls enables an easy and mistaken pressing of the wrong button. Above each button is a symbol (left side a power symbol and right side a magnetic symbol), however, these do not represent the buttons directly below them.

**Immediate Cause:** Human Error - Pushing of the wrong button.

**Root Cause:** Poor design of equipment

Similar button design in motor power button and magnet power button. Power symbol and magnetic button symbols above not correct in indication for use.

**Good Practice:** Ensure equipment is selected with user ergonomics and familiarity with the equipment in mind.
