## Description of incident:

Scaffold work activities were being carried out on an installation. The IP was in the process of constructing an outboard scaffold at the time of the event working on the top level of the scaffolding structure.

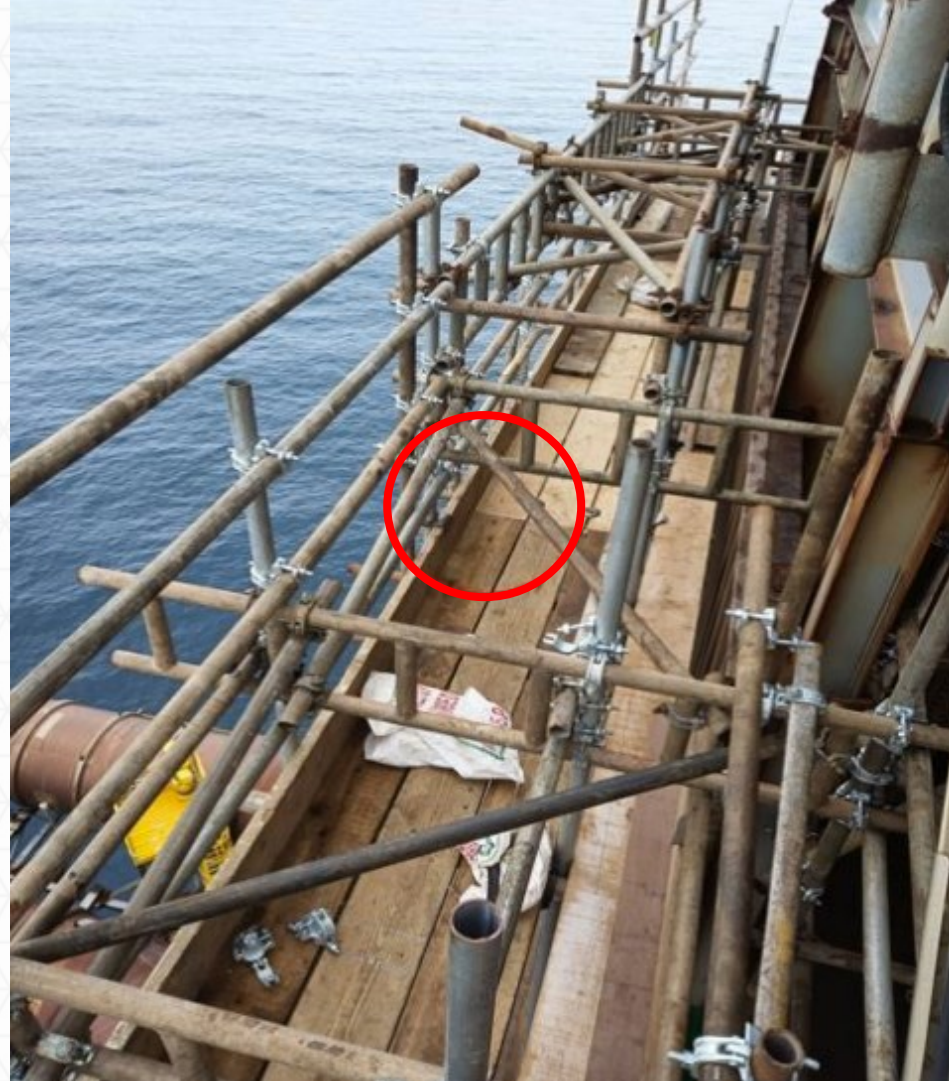
Space was restricted due to the cross sections and bracings. As the IP was walking across the scaffold platform carrying a 6-foot scaffold tube on their right shoulder, the IP tripped over a fixed scaffolding bracing.

This caused the IP to lurch forward, resulting in the IP's pinkie finger being caught between the scaffold tube that was being carried and part of the fixed scaffold structure.

There was restricted space in the area due to various cross sections and bracing at waist height.

**Planning** - As part of the planning process, personnel should ensure there is a sufficient amount of scaffolding tubes, etc., at each work location before work commences. Ensuring the correct resources are in place at the work location will minimise the risk of individuals having to perform unnecessary commutes / manual handling. Scaffolding should be designed/erected with access/egress in mind.

**Spatial awareness** – Carry out a Dynamic Risk Assessment / 20 second scan prior to commencing work scopes or if any change should occur.
